Sensitive Habitat Inventory Mapping and Aquatic Habitat Index

East Barrière River

March 2024

Secwépemc
Fisheries
Commission

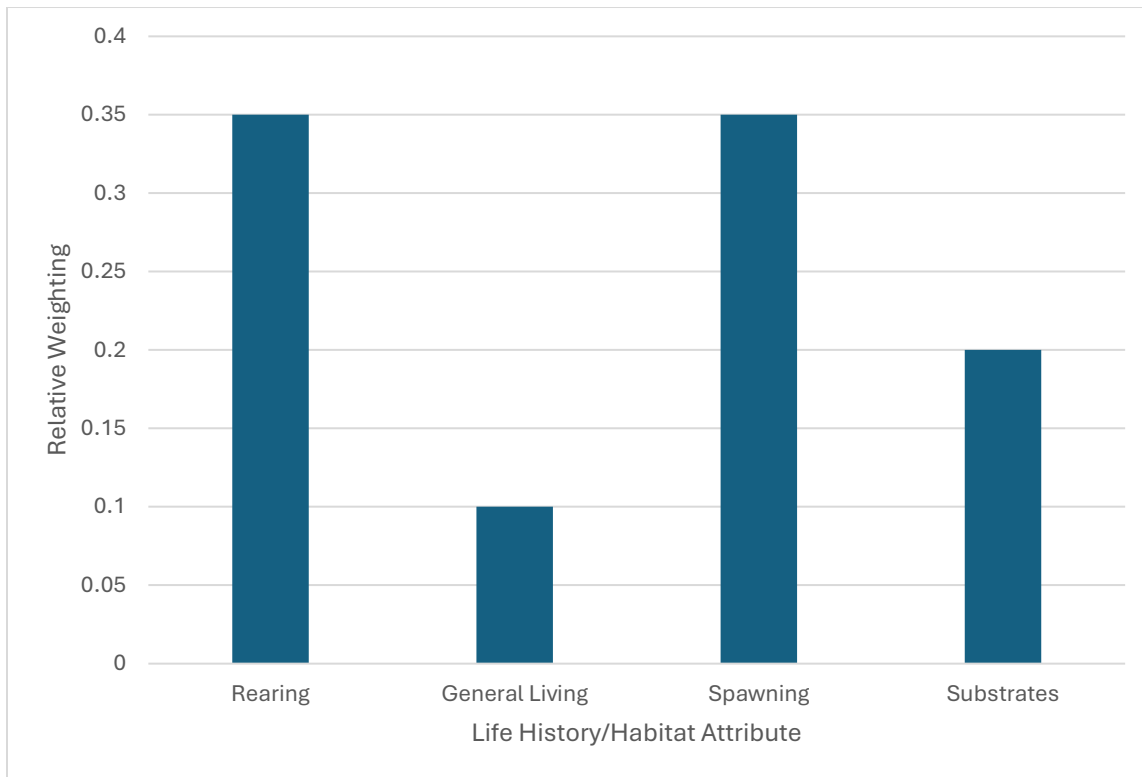
**Figure 2.** Relative weighting of a given life history stage or attribute.

The AHI adapted for the East Barrière River considered the life history stages of spawning, rearing and general living, as well as the habitat attributes of substrate (Figure 2). A score for each segment was calculated using the following equation:

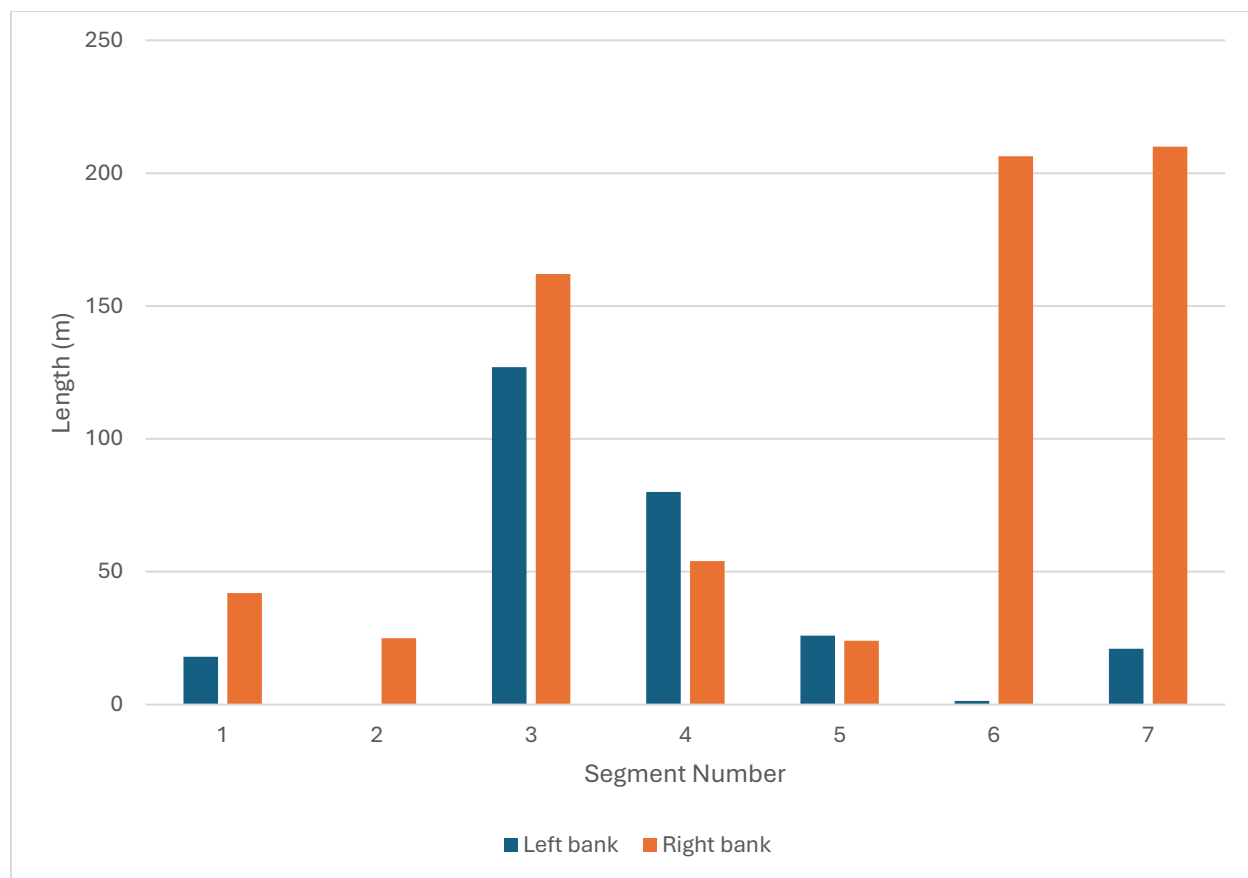
Segment 3 had the greatest total length of modified streambank (289 m) (Figure 4). Much of this disturbance appears to be from private landowners using heavy equipment instream to divert or alter flows. One particular property had done extensive damage to the streambanks and streambed. The property is located at the end of Creekside Road. Both banks and the streambed along approximately 120 m of the channel have been excavated, upturned, and channelized (Figure 5, Figure 6). A dam was constructed by depositing substrate at the upstream end of the disturbed area, creating a potential barrier.

Figure 4. Total length of modified streambank by segment in the East Barrière River.

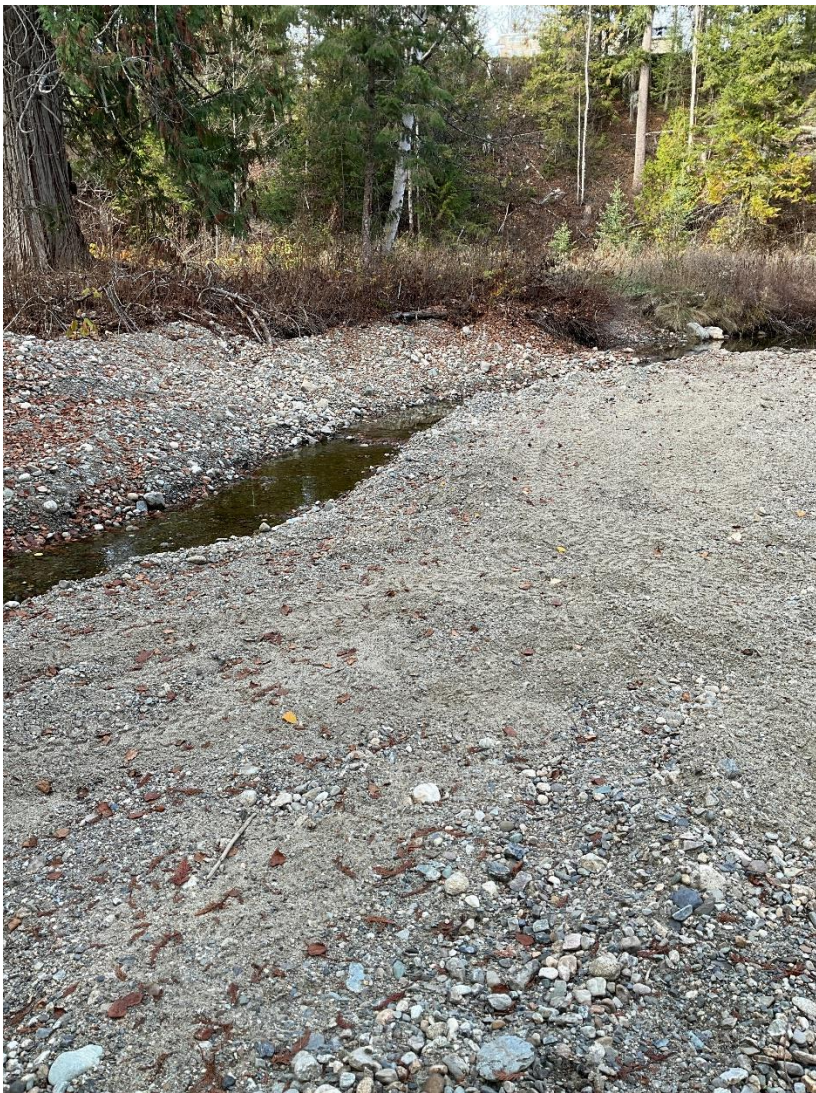
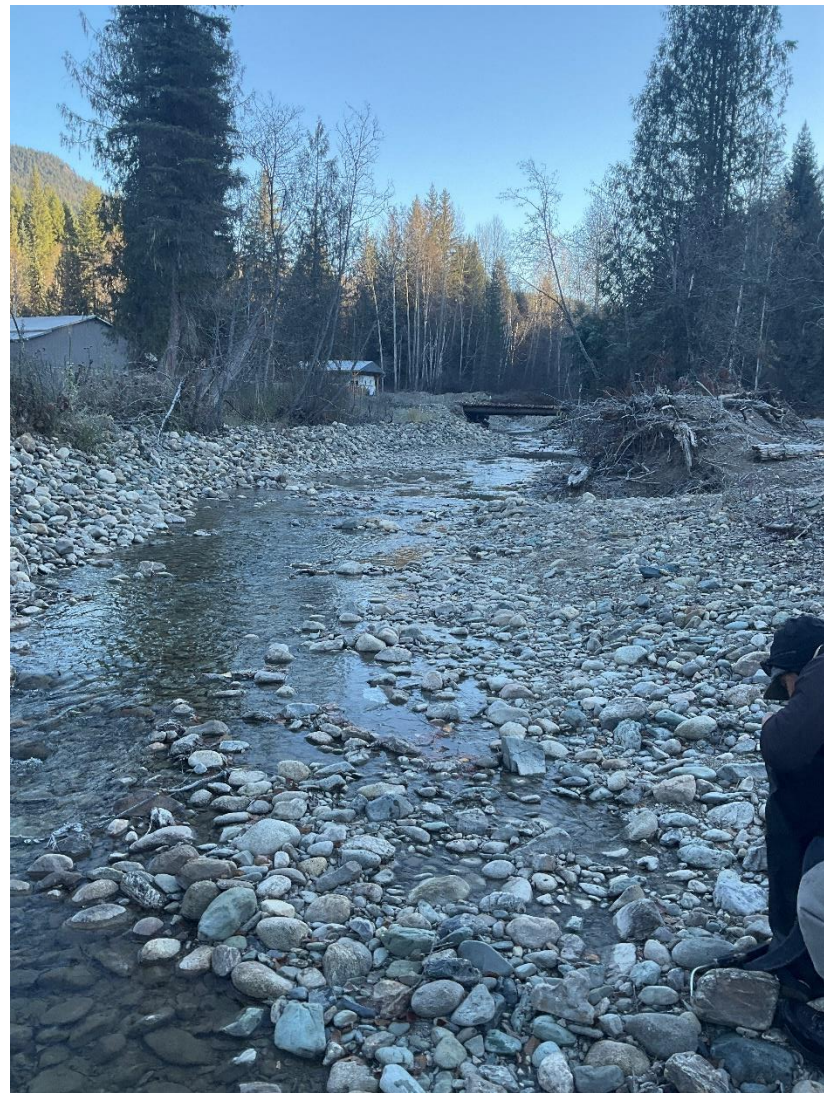
Figure 5. Gravel placement appears to have been placed to block a side channel and machinery tracks are visible instream (left). Riparian vegetation has been cleared, and bed material has been excavated along a property at the end of Creekside Road.

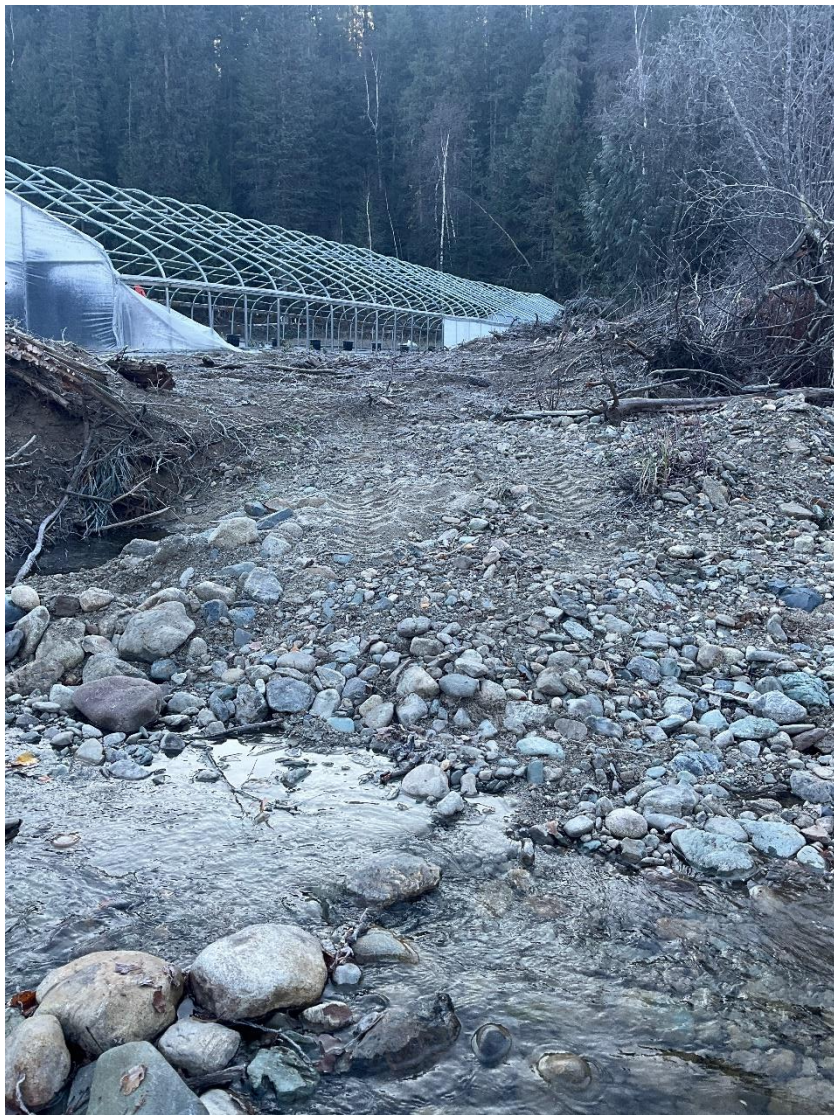
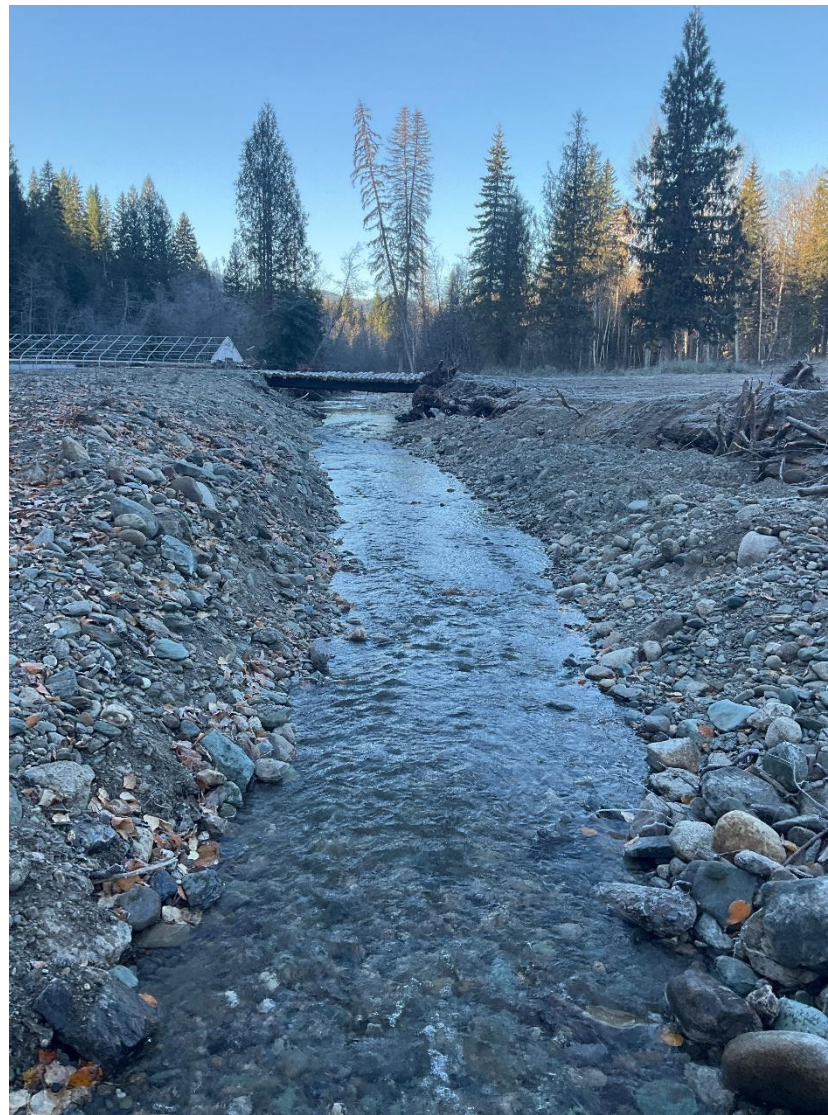
Figure 6. Machinery was used instream at the Creekside Road property (left) and the banks and bed of the river were excavated to channelize the river (right).

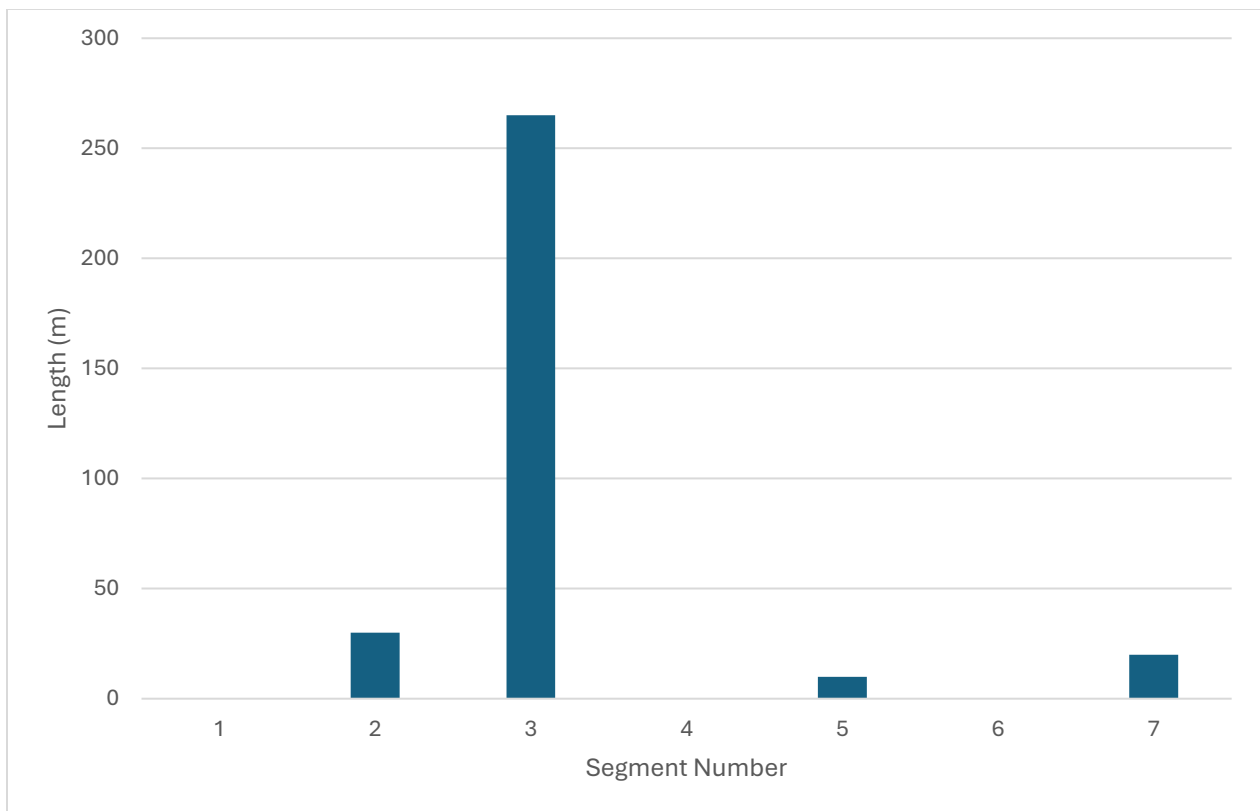
The most significant streambank erosion in the East Barrière River occurs in Segment 3 (Figure 7). Many of the eroding banks observed were the result of natural slope failures along incised segments (Figure 8). However, development and land clearing in Segment 3 has resulted in elevated and accelerated levels of erosion. Erosion and fine sediment mobilization is a concern in Segment 3 until substantial streambank restoration efforts are completed. These streambank alterations have a potential to impact downstream migration and spawning, egg incubation, as well as rearing and resident fishes.

The naturally occurring slope failures observed were on outside bends of high velocities areas. These occurrences were generally small and are not likely to present a large-scale introduction of fine sediment to the watershed (Figure 7).

Figure 7. Total length of eroding streambank in the East Barrière River.

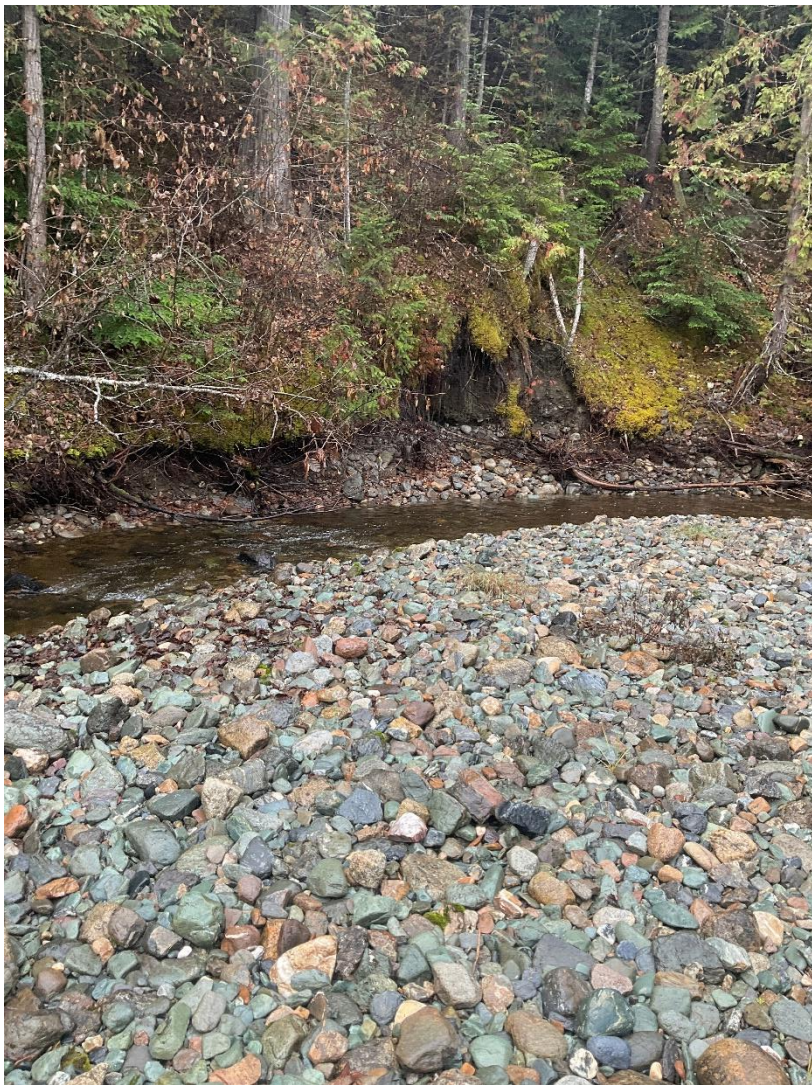
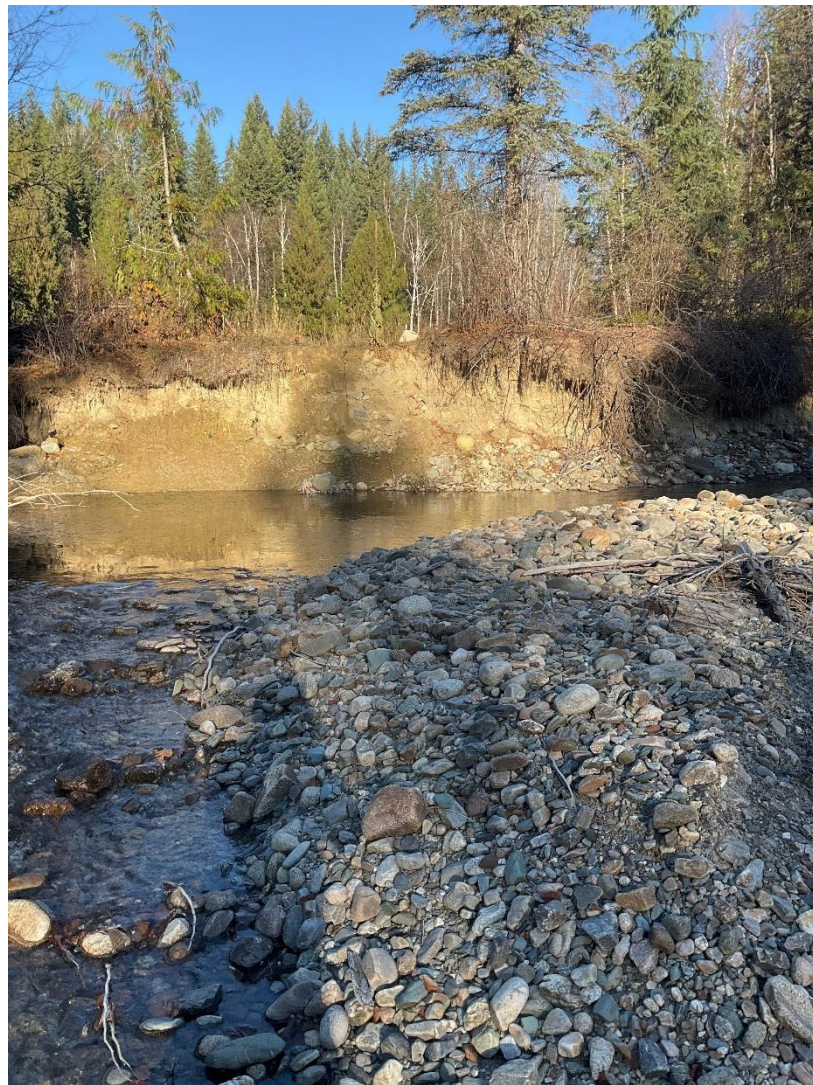
Figure 8. Natural incision (left) and accelerated downcutting (right) with riparian removal/thinning along the bank top.

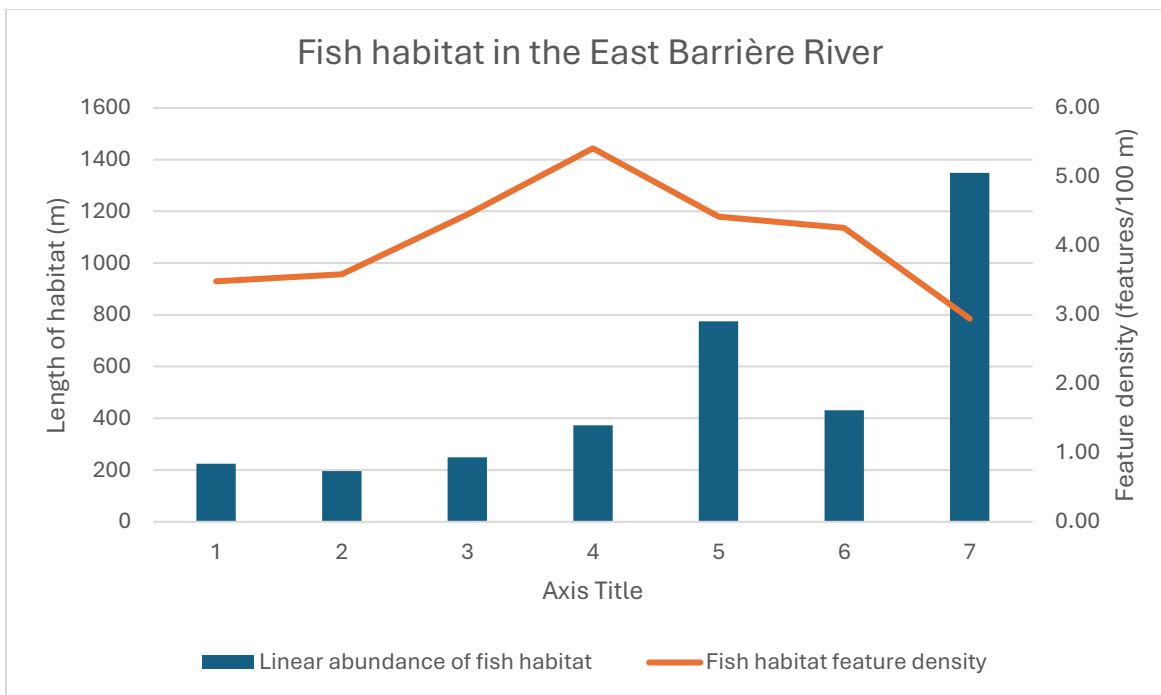
LWD was found throughout the surveyed stream length, while deep pools were abundant in Segment 7, and off-channels were most common in Segments 1, 3, and 6. Segments 5 and 7 were the longest segments surveyed and had the greatest total length of fish habitat features (Figure 9). Segments 3, 4, and 5 had the highest feature density (habitat complexity).

Figure 9. Distribution of the linear abundance of mapped fish habitat features (blue) and density of features (orange) in the East Barrière River.

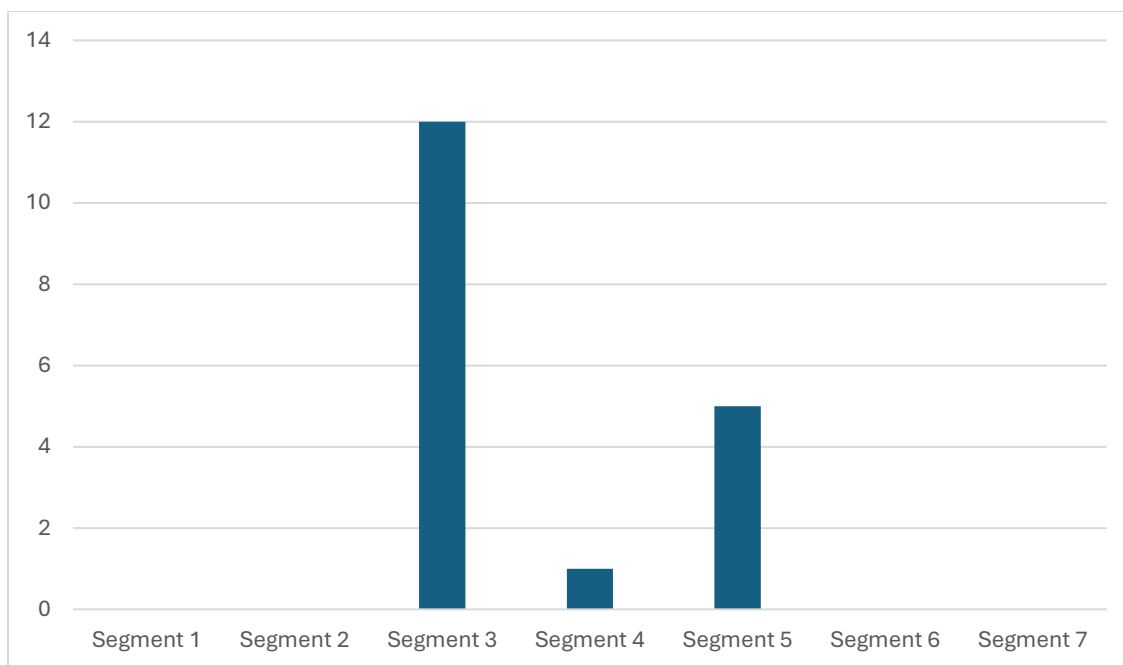
Hundreds of spent pink salmon carcasses were observed in Segment 1, but none were seen upstream of the bridge on South Barrière Lake FSR. Spawning and holding IFC were observed in upstream segments and these locations were mapped. Segment 3 had the highest abundance of spawning or holding coho salmon (Figure 10).

Figure 10. The number of spawning or holding IFC by segment observed during the 2023 SHIM survey on East Barrière River.
