Sensitive Habitat Inventory Mapping and Aquatic Habitat Index

Lemieux Creek

March 2023

**Secwepemc
Fisheries
Commission**

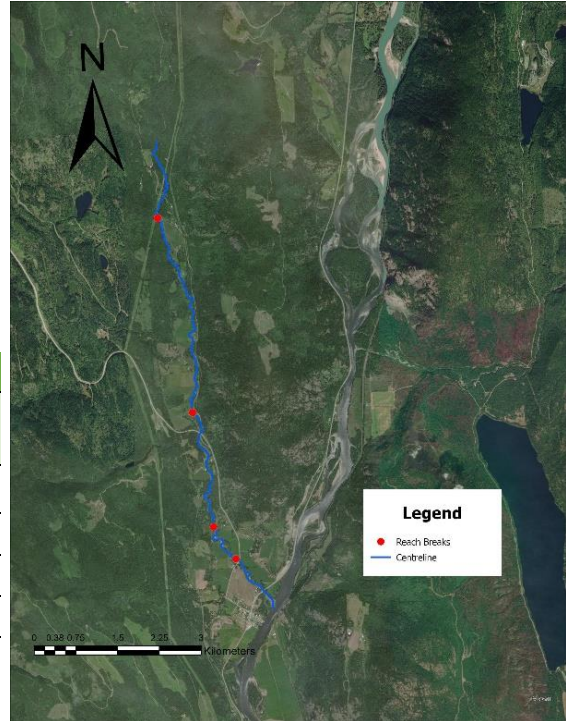
Five segments were designated over the 11.3 km of stream surveyed. Segment 1 begins at the mouth and extends 1.35 km to the bridge at Highway 24. Segment 2 begins just past the bridge and extends 1.03 km upstream, and Segment 3 extends another 2.73 km upstream. Segments 4 and 5 extend 4.46 km and 1.71 km along Lemieux Creek Road (Figure 1, Table 2).

Figure 1. Reach breaks delineating segments 1-5 in Lemieux creek.

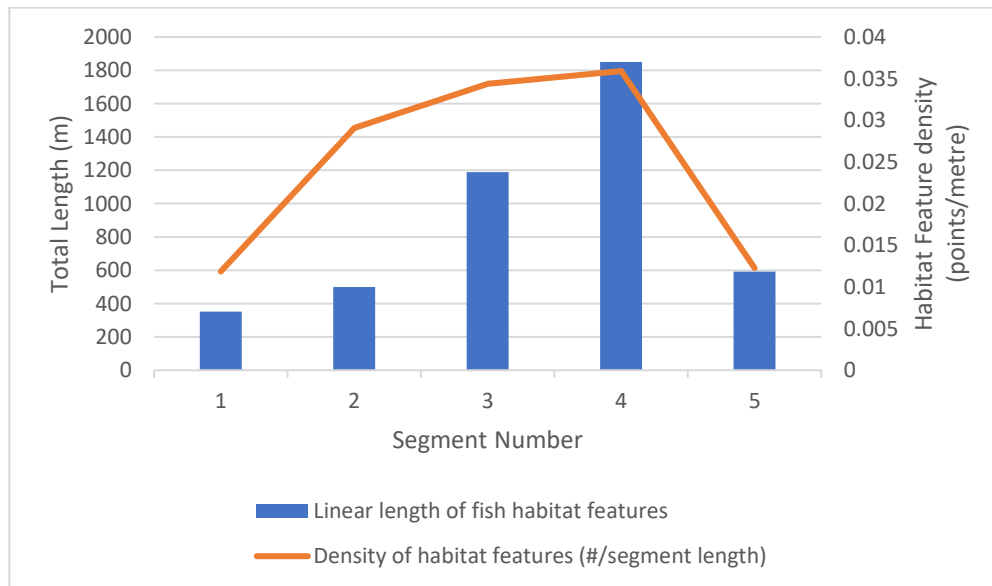
Lemieux Creek has suitable habitat for anadromous and resident salmonids. Deep pools and large woody debris (LWD) are the most common fish habitat features (Table 8). Juvenile salmonids require deep pools and areas of groundwater upwelling for overwintering habitat and late summer, low water refugia. Deep pools are important holding areas for migrants and provide cover to spawning and resident fish. The tail outs of pools are common spawning areas, since they offer cover to adults and are often sources of groundwater upwelling. Other important fish habitat features like off-channel habitat, instream and overstream vegetation were most abundant in Reach 4. The largest contributions to high quality fish habitat occurred in reaches 3 and 5, which also had the greatest habitat complexity (feature density) (Figure 4).

Figure 4. Distribution of total length of mapped fish habitat features (blue), and density of features (orange).

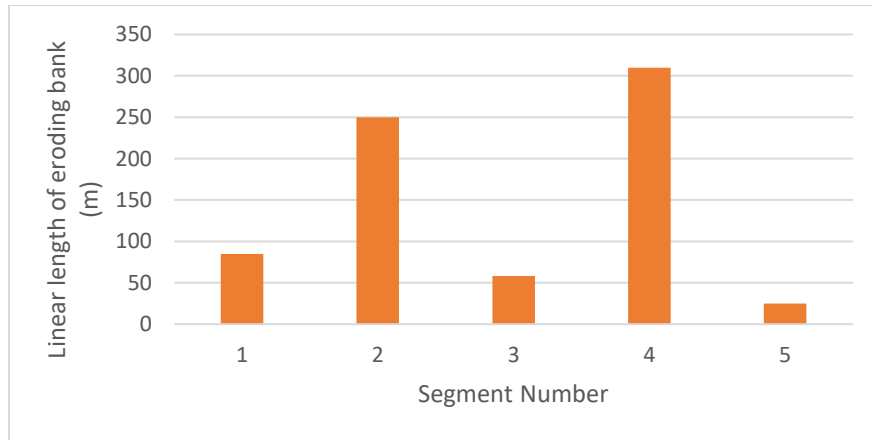
The most significant erosion in Lemieux Creek occurs in segment 4 (Figure 5), where there is a high level of disturbance from agriculture and linear development. Much of the erosion in segments 2 and 4 is the result of livestock grazing and a lack of riparian vegetation (Figure 6). These areas of high disturbance facilitate the establishment of invasive species like knapweed, tansy, burdock, and reed canary grass. Decreased riparian vegetation leads to bank erosion, downcutting, increases in surface water velocity, and further prevents natural revegetation. Impacts from linear development can also lead to increases in water velocity, bank erosion, and other downstream effects like elevated compaction and embeddedness of substrate (Figure 7).

Figure 5. Total length of eroding streambank by segment.

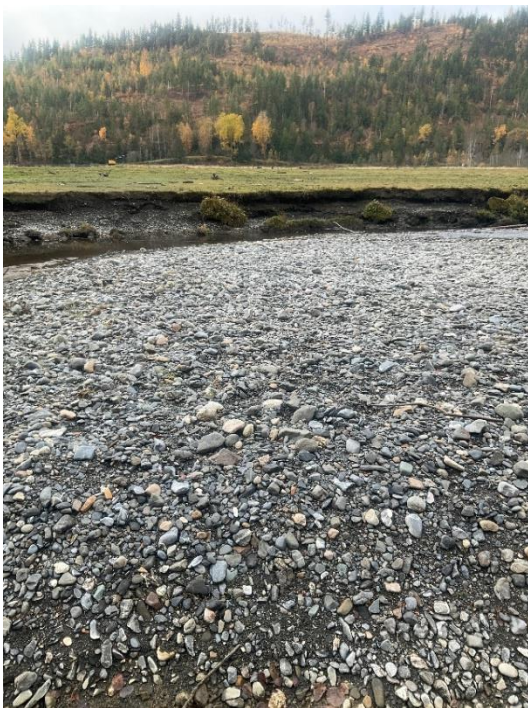
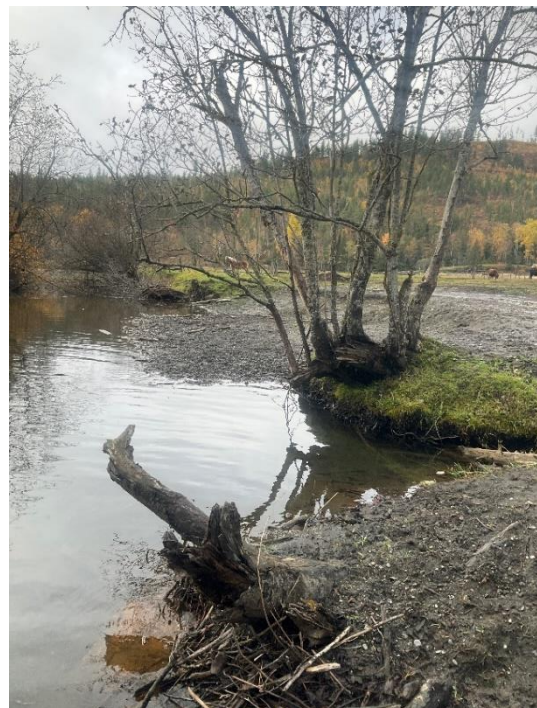
Figure 6. Above: Erosion resulting from livestock access and grazing of riparian vegetation.

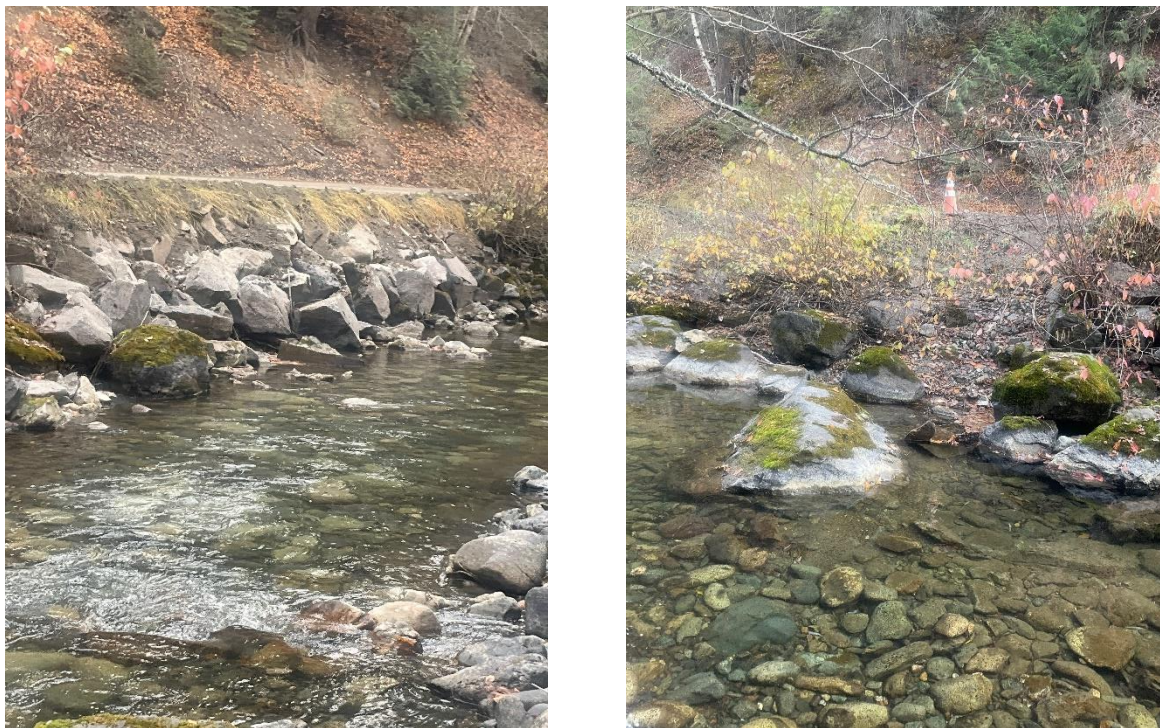
Figure 7. Left: The severe bank steepness along the road has prevented riparian vegetation from taking hold and resulted in riprap collapsing into the stream. Right: A pylon demarks risk to motorists where the road is collapsing into the stream.

Action 3: Address the degrading road infrastructure in segment 3.

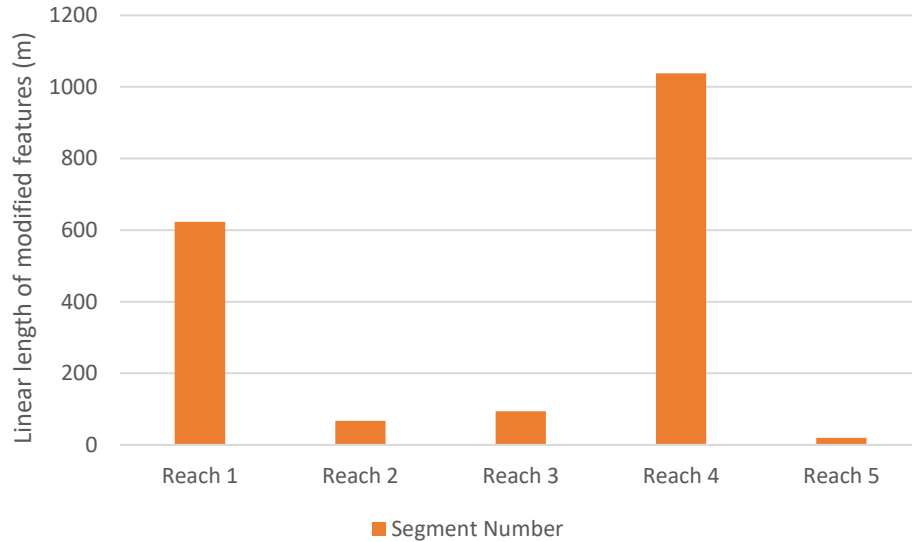
Habitat modifications were recorded as point features and are summarized in Table 9. Riprap and bank stabilization efforts, along with livestock access points are the most common modifications to the channel. Segments 1 and 4 are the most heavily modified (Figure 8).

Figure 8. Total length of modified features by segment.

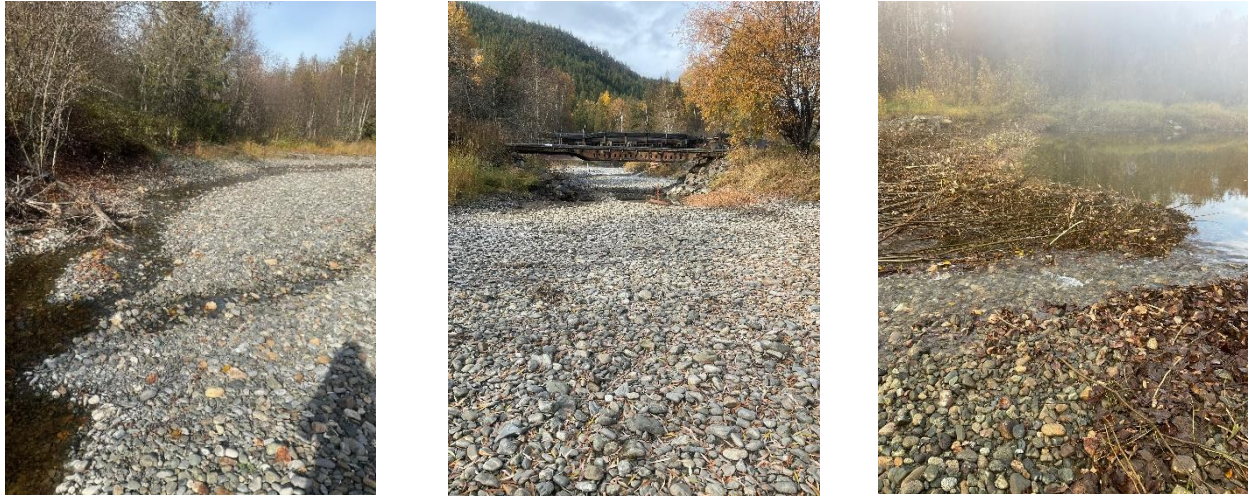
Periodic dewatering at the mouth and in segment 4 (approximately 7 km upstream) has been reported. SFC observed these conditions at the time of the SHIM. The stream went subterranean at several points in Segment 4, remaining dry for stretches up to 500 m long (Figure 9). Water at the mouth was extremely shallow and fanned out, requiring sandbagging by crews to confine flows and create depths that allowed fish passage.

Figure 9. Above: Water depths became too shallow for fish passage (left) and eventually dried up (middle). A beaver dam at the mouth was monitored and partially removed to allow adult migration (right).

Action 2: Monitor flow and fish passage conditions at the mouth.

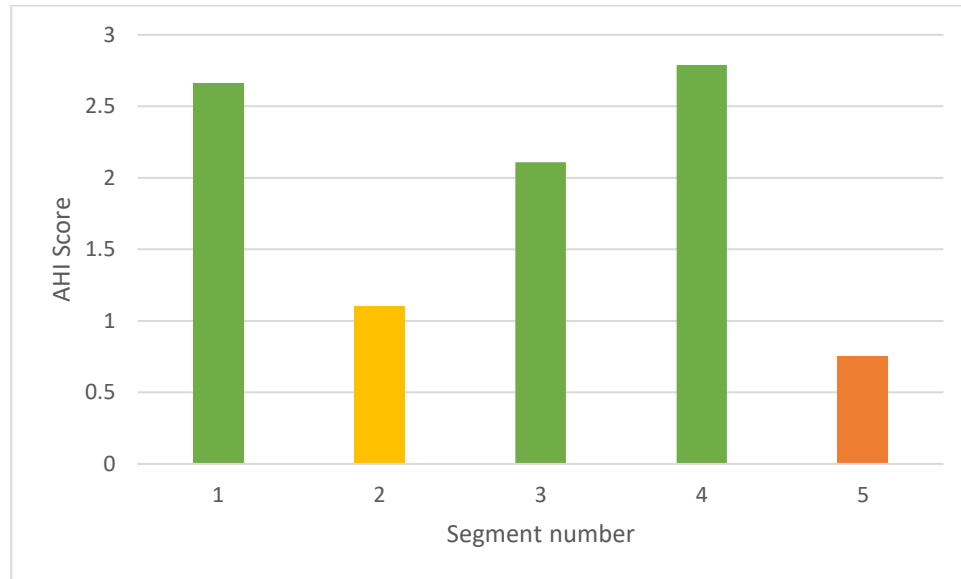
The centreline AHI results are outlined in Figure 10. The AHI generated considered not only the amount of fish habitat features, but the relative value of each feature to the key fish species in Lemieux Creek. Segment 4 had the highest fish habitat value, making the greatest contribution to the overall aquatic habitat quality of the surveyed area.

Figure 10. AHI Segment Scores.

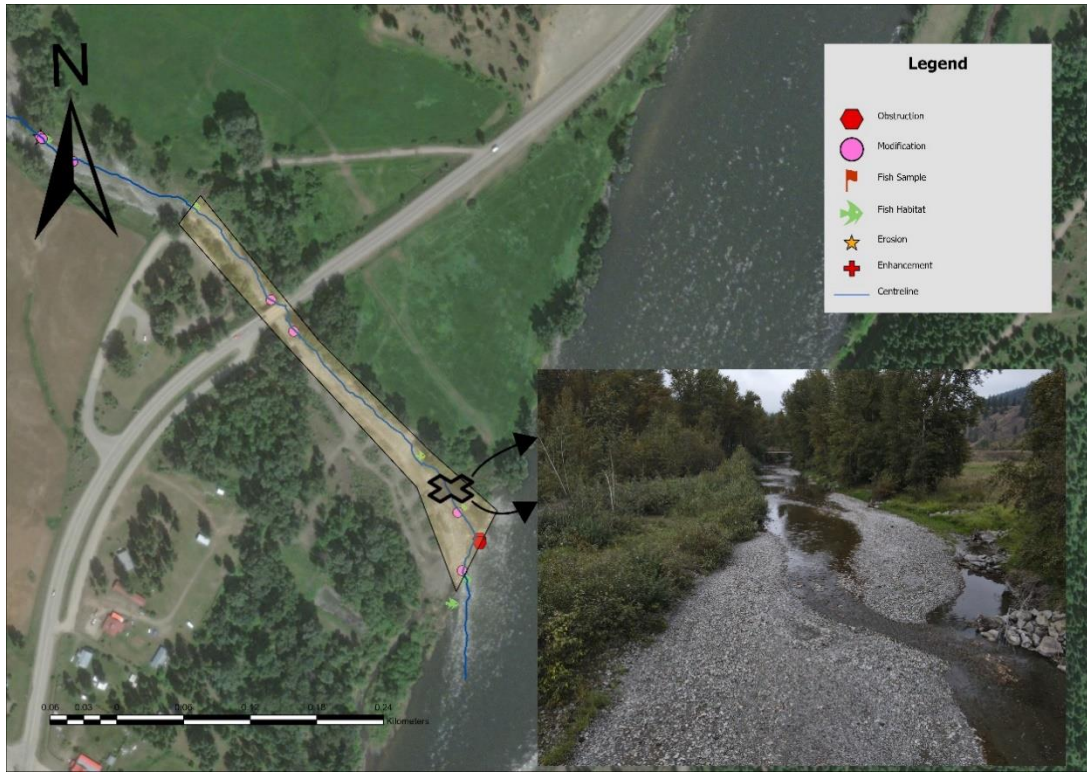
Figure 12. Restoration Opportunity 1.

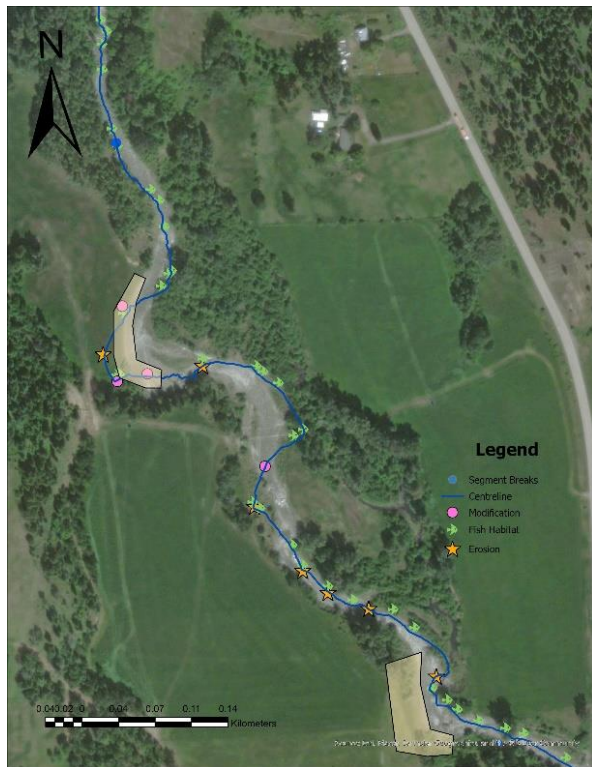
Figure 14. Restoration opportunities 2 (downstream, lower right polygon of map) and 3 (upstream, upper left polygon in picture).

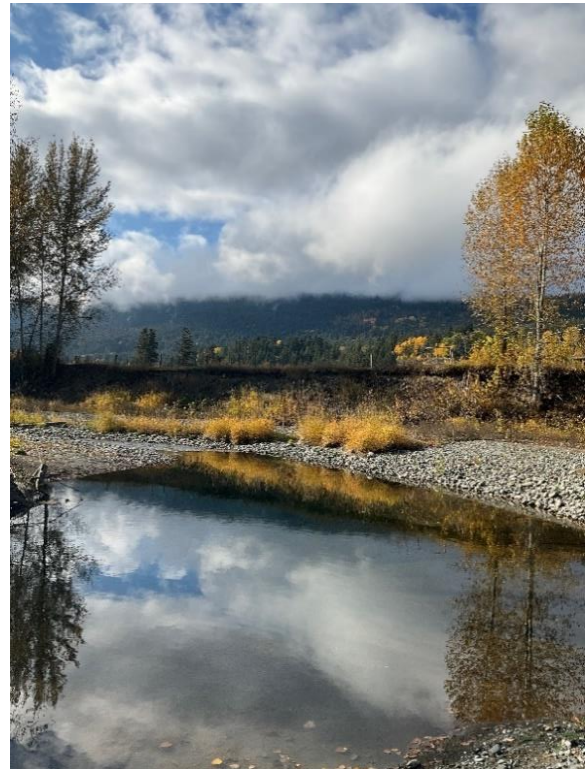
Figure 13. Restoration opportunity 2.

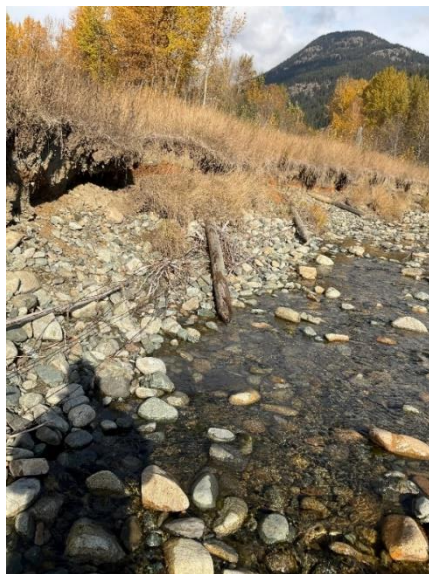
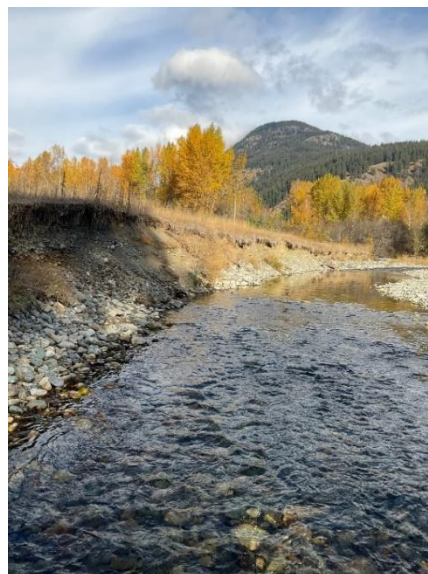
Figure 15. Restoration opportunity 3 (left and right).

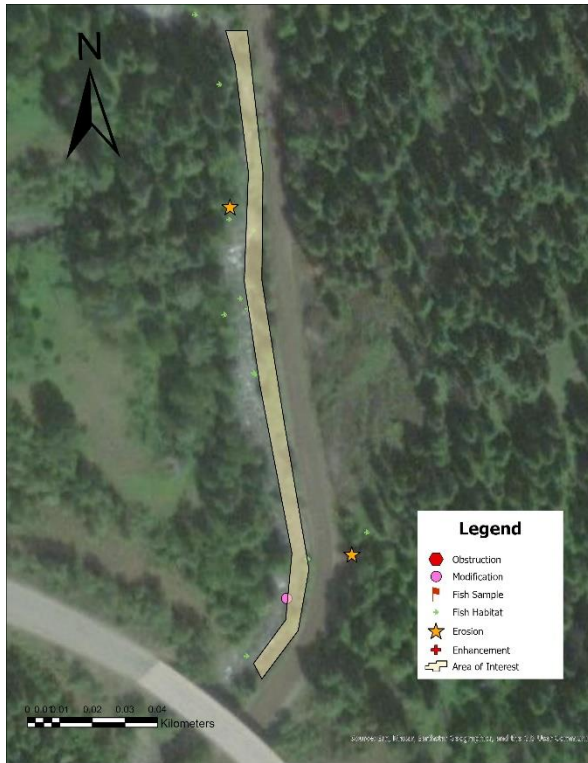
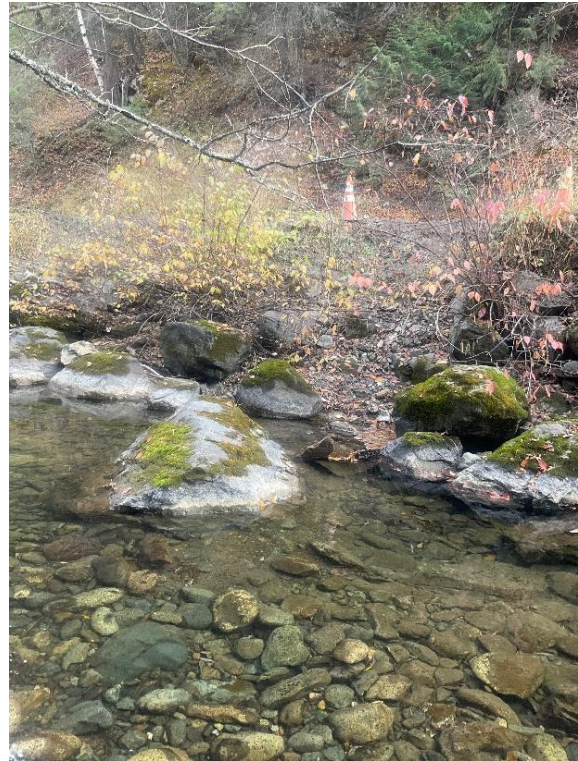
Figure 16. Above: Restoration opportunity 4. Left: map outlining the area of interest. Right: A cone was placed by road crews to mark a section of collapsing road.

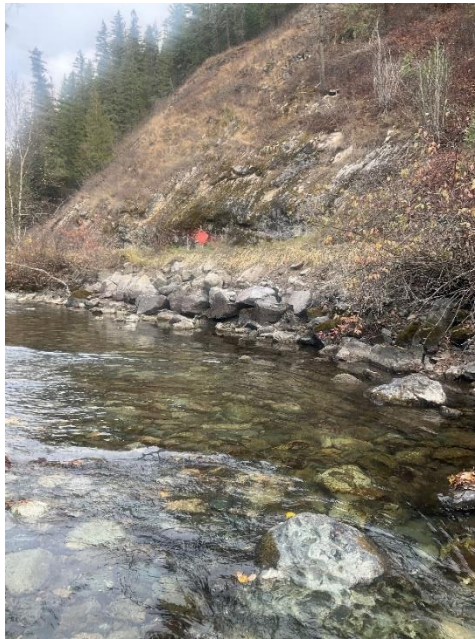
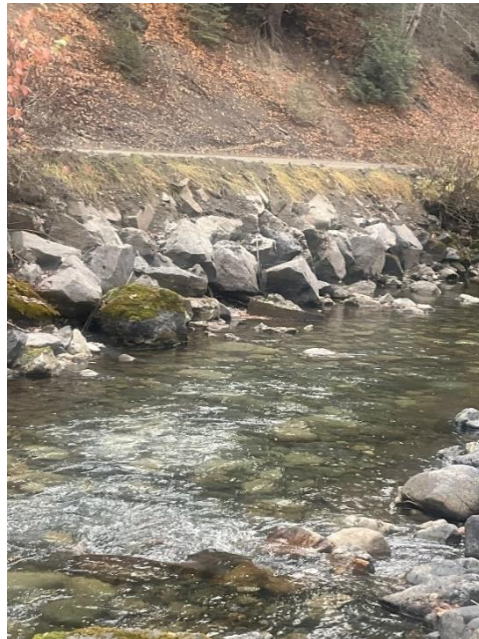
Figure 17. A long section of riprap along the road confines the stream. The banks are too steep for vegetation and are sloughing road material into the creek.

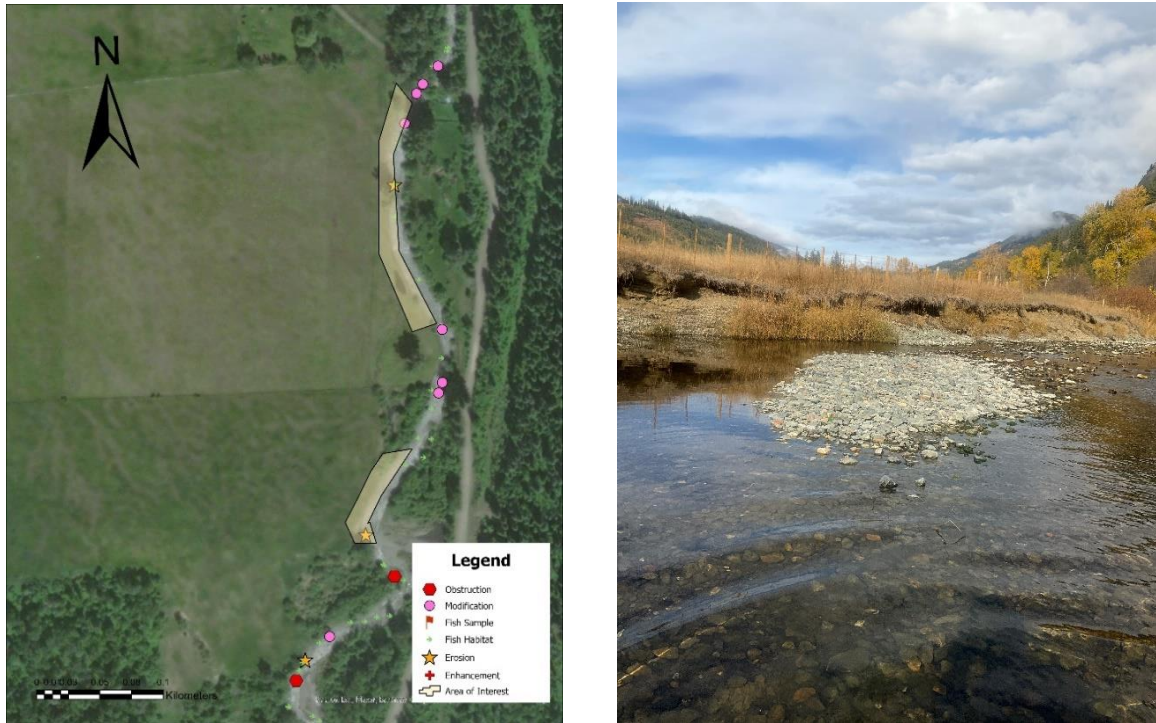
Figure 18. Left: Restoration opportunity areas of interest. Opportunity 5 is located downstream (lower polygon pictured), and opportunity 6 is located just upstream (upper polygon pictured). Right: Collapsing banks of restoration opportunity 5.

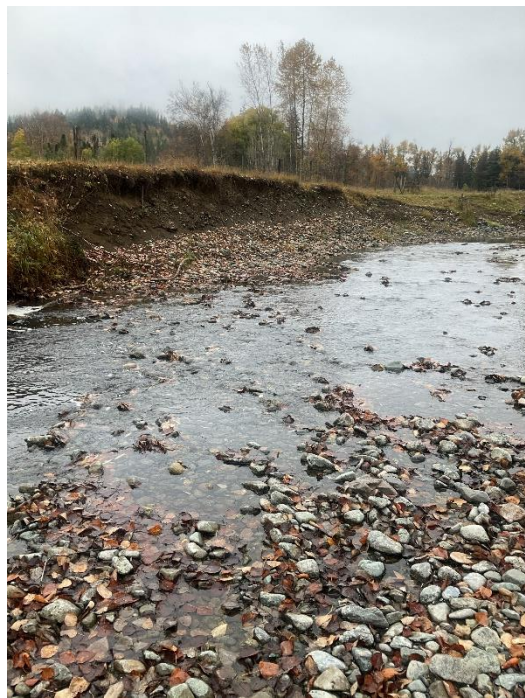
Figure 19. Eroding banks and cattle access of restoration opportunity 6.

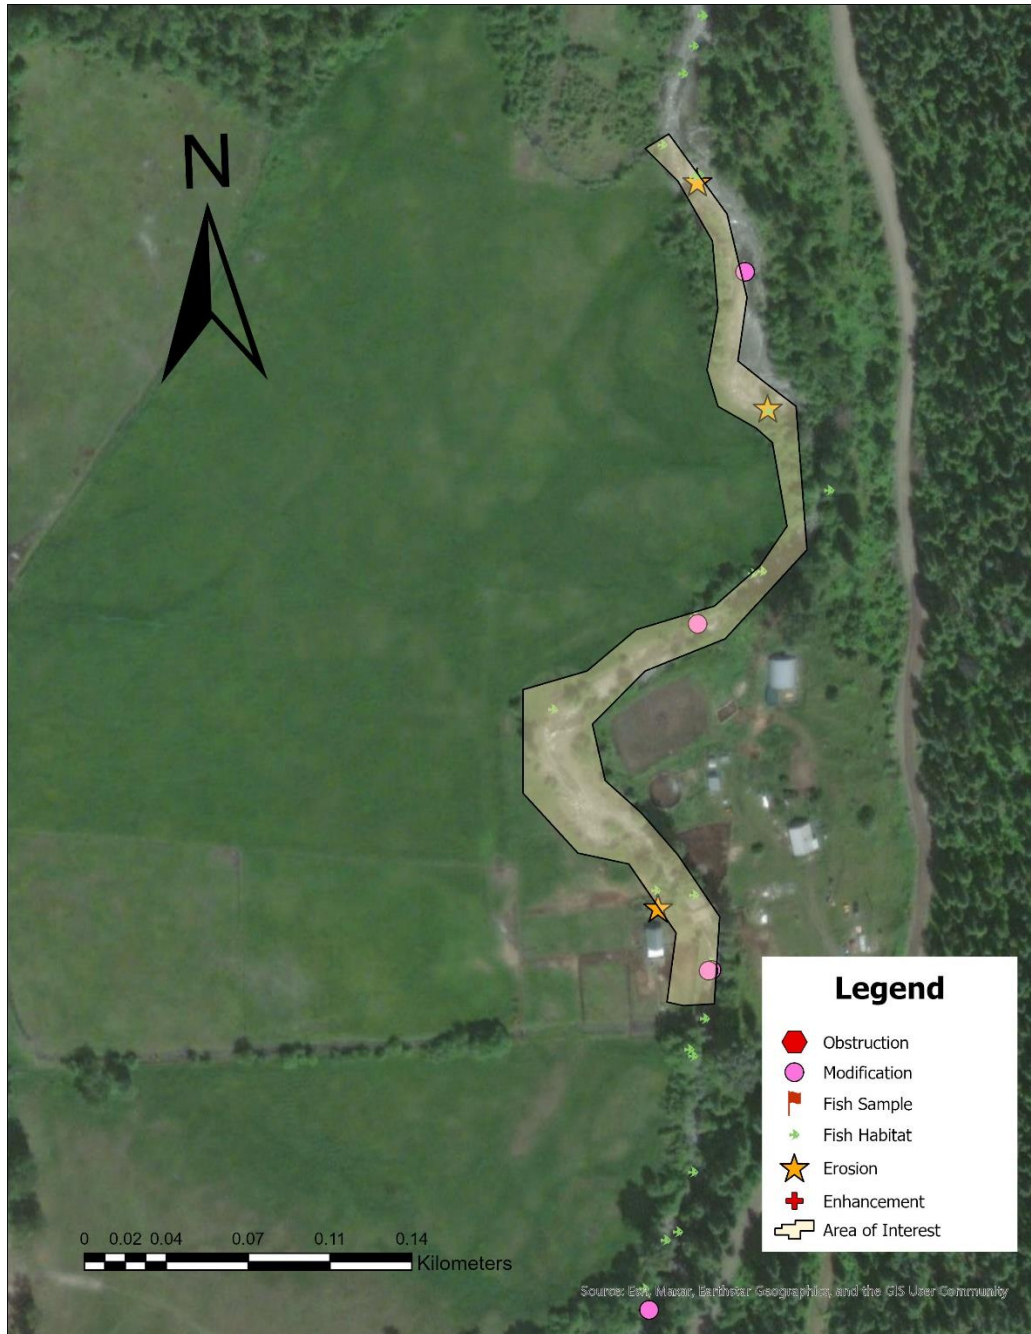
Figure 20. Restoration Opportunity 7.

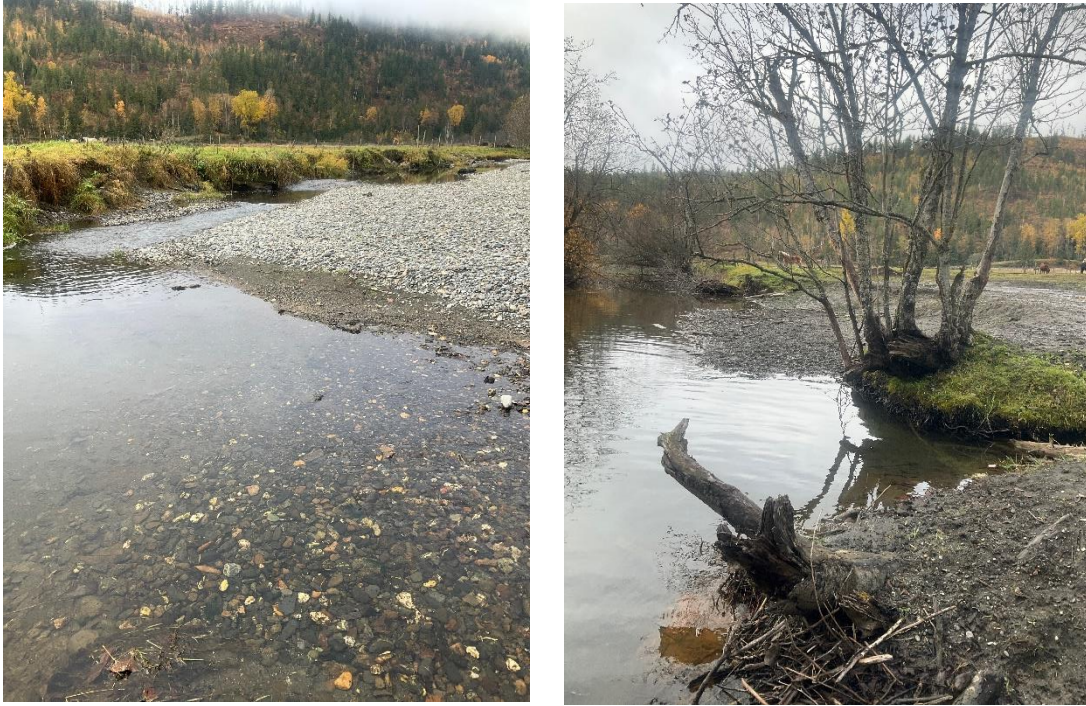
Figure 22. Above: Eroding banks and livestock access of opportunity 7.

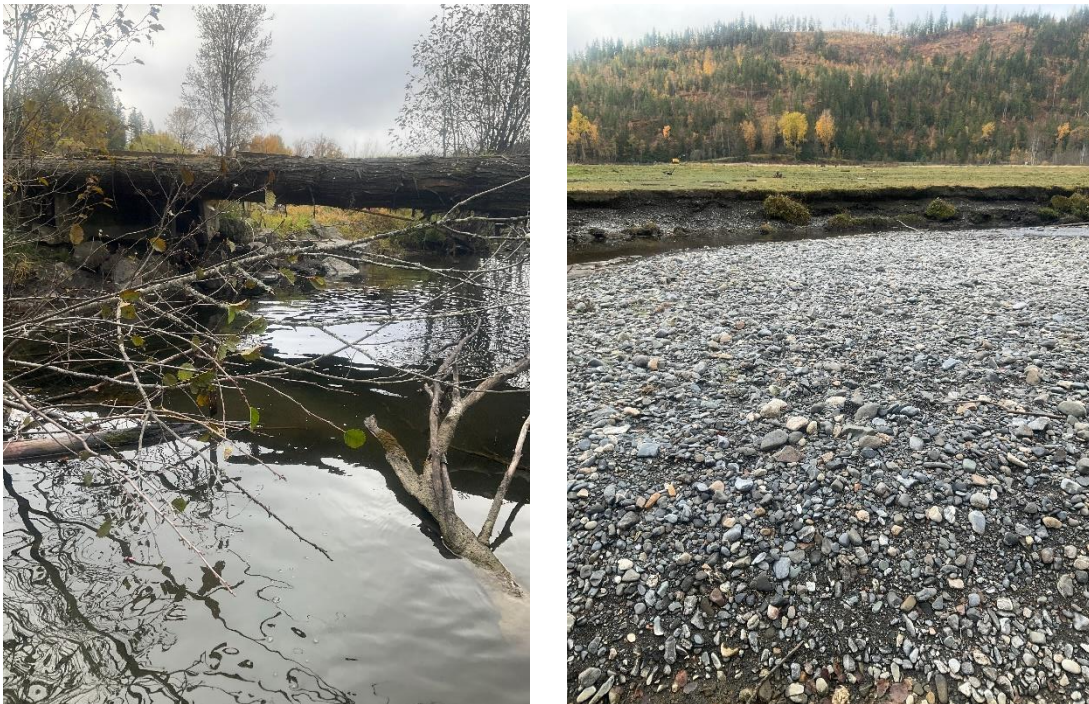
Figure 21. Left: Dilapidated bridge at opportunity 7. Right: Eroding banks and livestock access of opportunity.
