# Sensitive Habitat Inventory Mapping and Aquatic Habitat Index

## Tranquille River

March 2023

**Secwepemc  
Fisheries  
Commission**

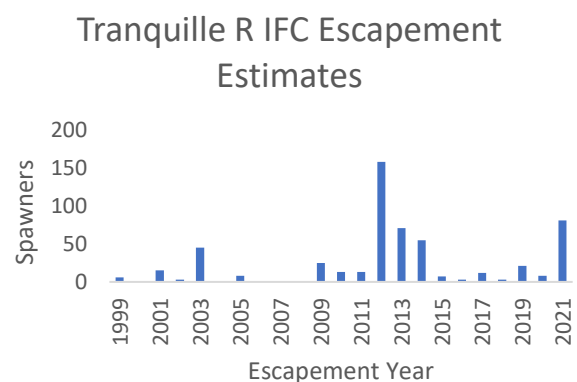
Figure 1. SFC stream-walk survey data for Tranquille coho.

Populations of Interior Fraser Coho (IFC) are supported in the lower reaches of Tranquille River, within the Lac du Bois Park (Figure 1). It is also an important river for resident rainbow trout, Kamloops Lake rainbow trout and headwater lake residents. Chinook and kokanee salmon have been documented within the system at multiple life stages (Table 4). Chinook, pink and kokanee salmon have high fisheries and cultural value; however, there is a lack of escapement data, and it is less clear the extent to which these species use the river. As a result, chinook, pink and

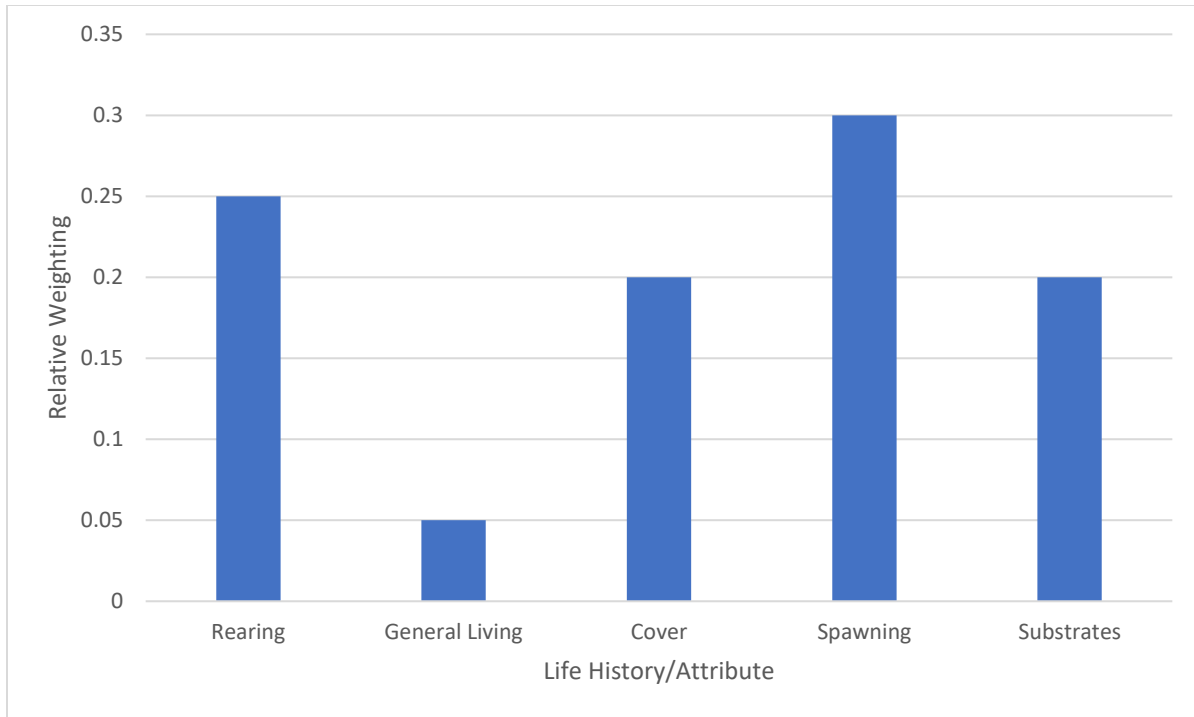
Figure 2. Relative weighting of a given life history stage or attribute.

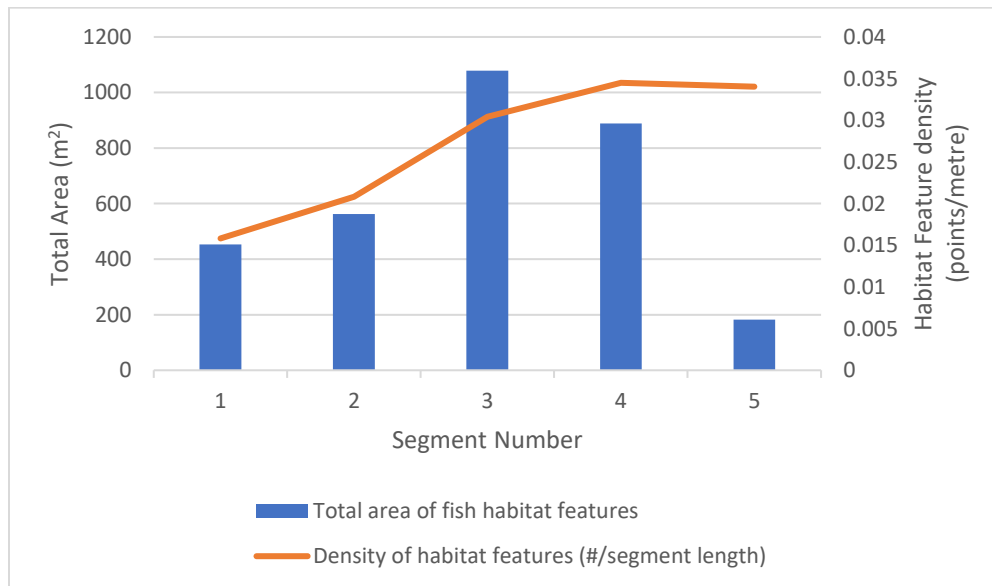
Figure 3. Distribution of total area of fish habitat features mapped (blue), and density of features (orange).

The Tranquille River has suitable habitat for coho and rainbow trout, with deep pools and large woody debris (LWD) being the most common fish habitat features (Table 8). Juvenile salmonids require deep pools and areas of groundwater upwelling for overwintering habitat and late summer, low water refugia. Deep pools are important holding areas for migrants and provide cover to spawning and resident fish. The tail outs of pools are common spawning areas, since they offer cover to adults and are often sources of groundwater upwelling. Over 80% of the total area of deep pools is located upstream of the water diversion structure. The total area of fish habitat features is greatest in segments 3 and 4 and the density of habitat features (complexity) is highest above the water diversion structure (Segments 3, 4 and 5) (Figure 3). No spawning fish were observed because low flows and braiding prevented coho from entering Tranquille at the mouth. Other important fish habitat features like off-channel habitat, instream and overstream vegetation were less abundant and could be the focus of future restoration efforts.

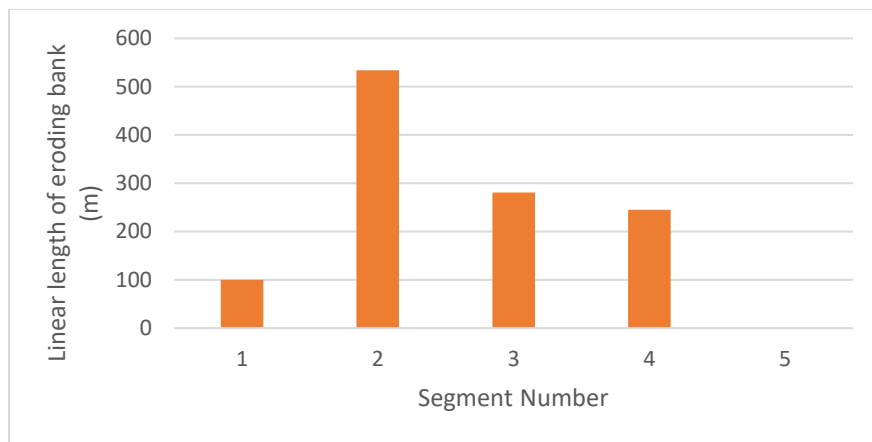
Figure 4. Total length of eroding streambank by segment.

Much of the erosion in segments 3 and 4 is the result of the confined nature of the channel, and natural bed and sediment mobility. As such, they are not suitable targets for restoration. The most significant erosion in Tranquille River occurs in segment 2 (Figure 4), where there is a high level of disturbance from recreation, linear development and the legacy effects of placer mining. Over a century of large-scale and recreational placer mining in the Tranquille River has disrupted the alluvium and natural geology of the channel. Large cobbles which would normally appear in the stratum below gravel, soils and organics, instead lay on the surface (Figure 5). This increases surface water velocity, prevents natural revegetation and leads to the erosion of streambanks in many areas. These areas of high disturbance facilitate the establishment of invasive species like knapweed, tansy and burdock. Sections of exposed banks are attractive areas to recreational gold panners who further excavate and weaken the streambanks (Figure 6). This leads to continued bank erosion and disturbance of riparian vegetation.

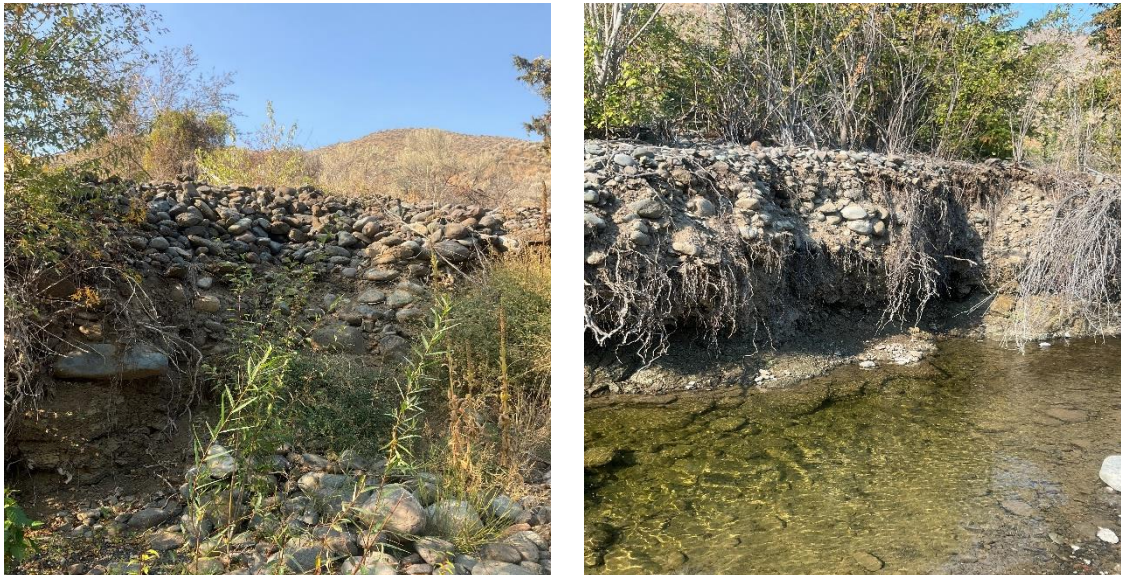
Figure 5. Above: Piles of cobbles lay on the surface of the soil stratum, delaying revegetation and contributing to bank erosion.

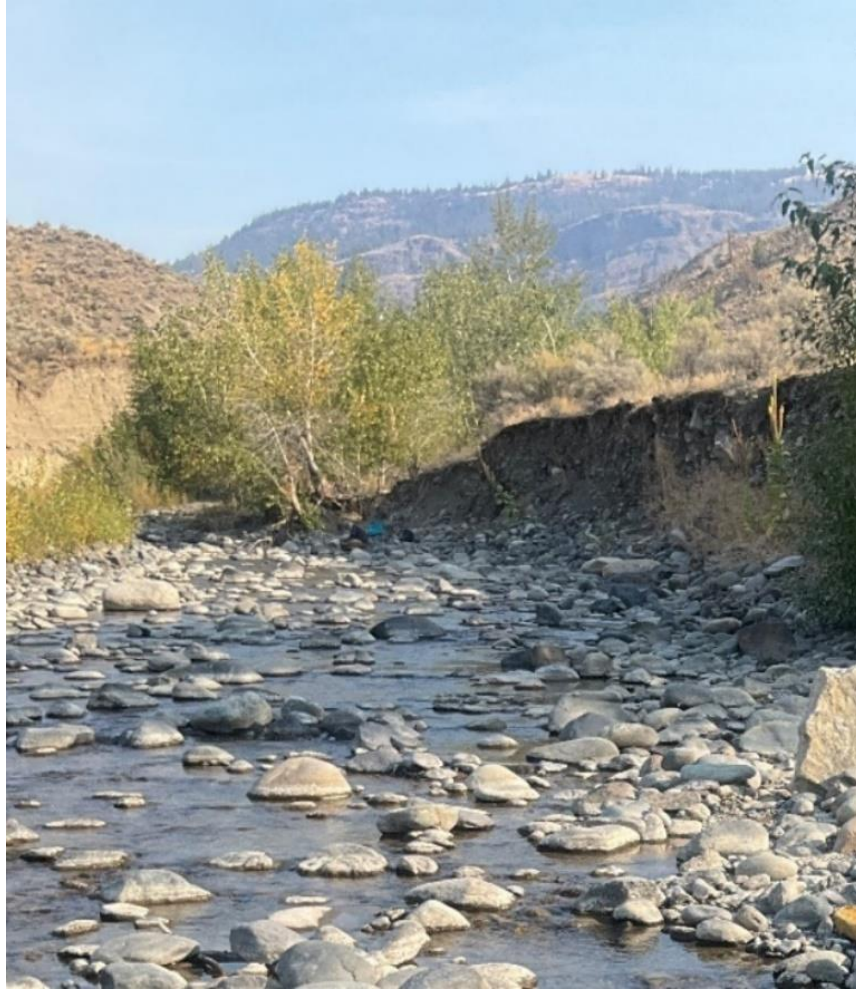
*Figure 6. Fast moving waters during freshet and impaired riparian zones result in deep, down-cut, eroding banks. Areas of exposed banks are commonly targeted by gold panners, which can be seen in the background of the picture.*

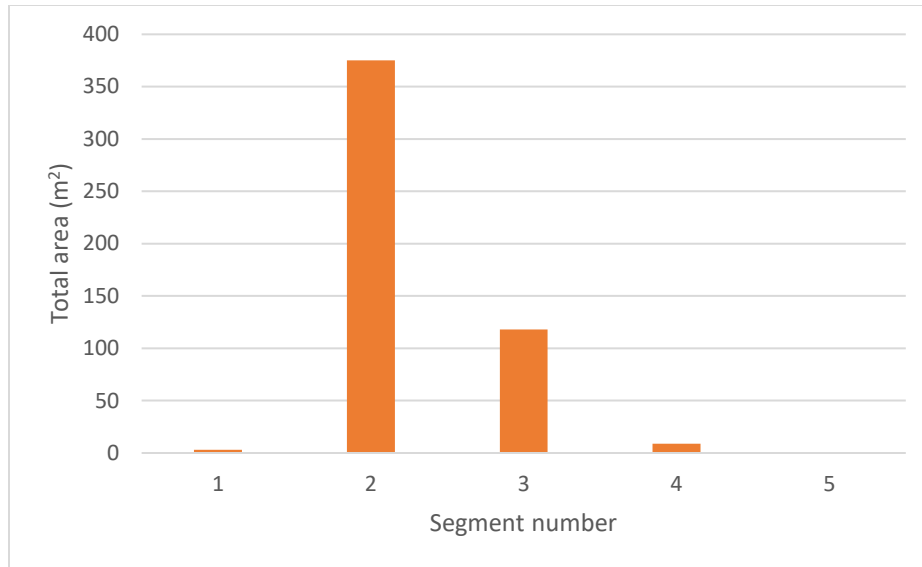
Figure 7. Total area of disturbed streambed and banks disturbed by gold panning.

Considering the conflict between the effects of recreational gold panning and these policies, the SHIM sought to identify sites of recent recreational gold panning within bankful width. These sites were mapped, and length and width were recorded. The total area of mined sites is represented in Figure 7 below. The highest frequency and the greatest total area of panning occurred in segment 2, followed by segment 3. This is likely due to their proximity to the parking lot area. The size of the gold panning excavations ranged from a bucket full to several square metres. The largest site was approximately 50 m<sup>2</sup> and consisted of a series of rock weirs and pits. Most excavations were an average of 1-4 m<sup>2</sup>. Historic placer spoils were noted where they were observed along the channel, however their total magnitude was not mapped since they often extended beyond 50 m from the streambanks. One notable area was located just upstream of the water diversion structure (Figure 10). It is at the tail out of a confined section of canyons where the valley widens slightly. Such areas were commonly targeted by prospectors because they are deposition zones where gold and other transported sediments would settle out in a predictable fashion. Placer mining effectively turns the streambed upside down, leading to larger substrates on top, channel confinement, reduced floodplain connectivity, and impaired riparian areas.

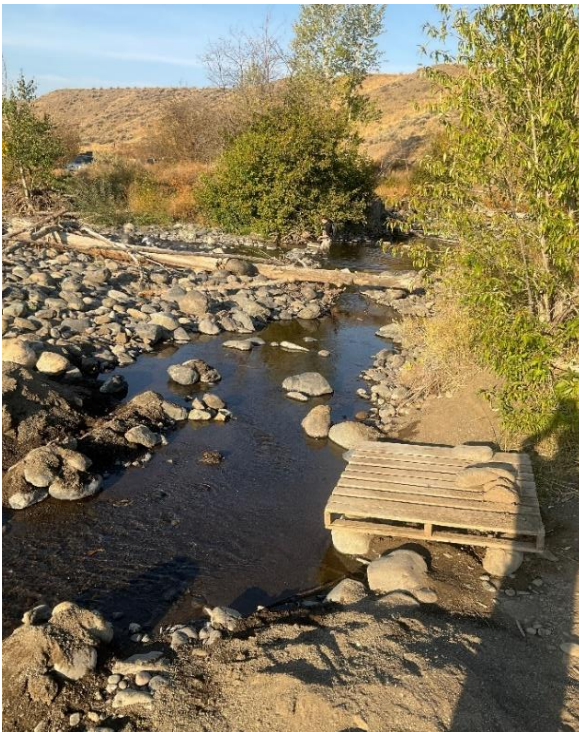
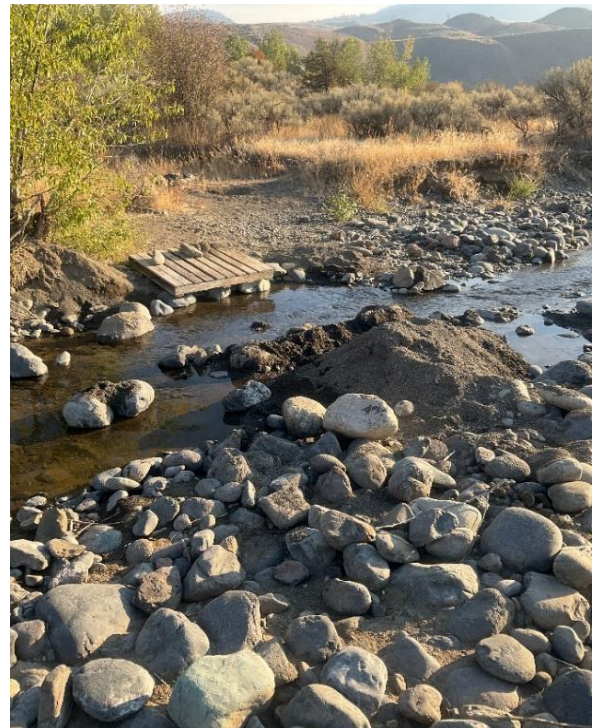
Figure 8. A channel was excavated (left) to divert water to a dig site approximately 3 m long and 1.5 m wide (right). Note the heaping pile of fines in the river.

- Considering the unique social, cultural, traditional values, and ecological values of the Tranquille River within the surrounding Ponderosa Bunchgrass Zones, gold panning is not recommended as an acceptable park activity. Gold panning was found to have a significant negative impact on aquatic habitat and riparian zones within the surveyed stream length.
- Clearly defined principles and policies will help clear ambiguity regarding park use and help protect special natural features.

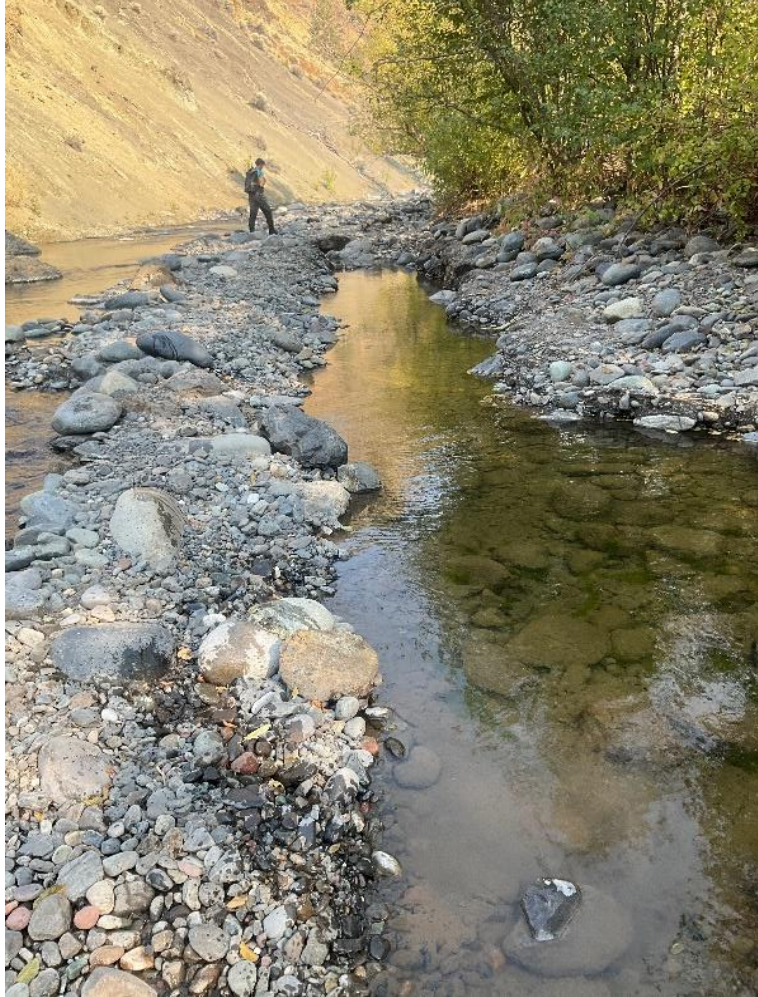
*Figure 9. A technician inspects one of the largest dig sites, measuring over 15 m long and up to 2 m wide.*

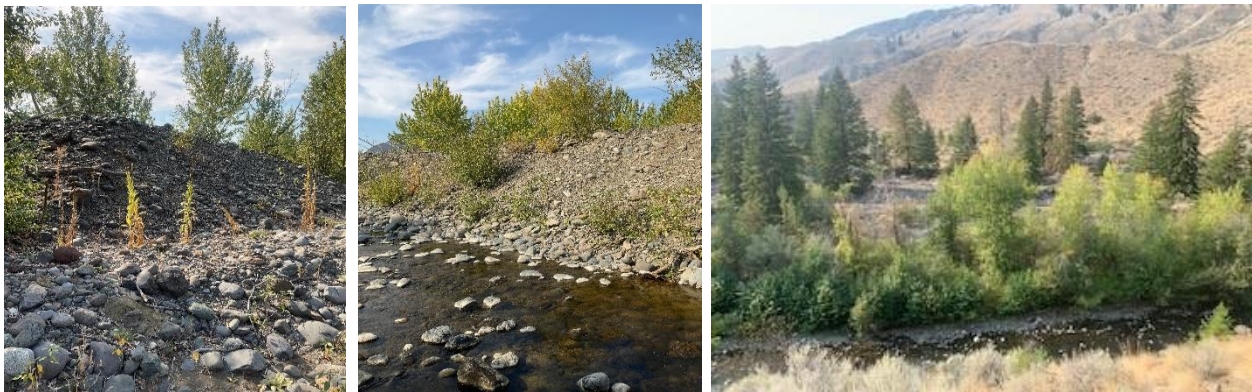
*Figure 10. Above: Historic placer tailings confine stream flow and increase water velocities. They prevent revegetation, healthy riparian zones, and flood plain connectivity.*

- Stage Zero or “Process-Based-Restoration” (PBR) is a low-tech, holistic restoration method that utilizes natural processes (transport and deposition) to return watercourses to pre-disturbance condition. It may represent the most long-term, sustainable approach to restoration when compared to traditional methods like rock-log structures and bank armouring. It attempts to fully reconnect a river to its former floodplain and is increasingly being used by the US Forest Service. More information can be found here: <http://stagezeroriverrestoration.com/>

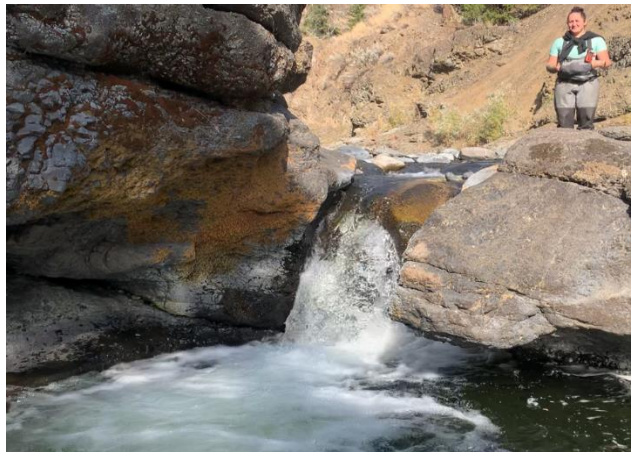
Previous reporting indicated that fish passage was obstructed at the 5-7 km mark by a series of waterfalls. The SHIM conducted by SFC revealed three small waterfalls approximately one metre high (Figure 11). These falls are all the result of boulders becoming lodged in the bedrock and steep canyon walls. It is possible they change slightly each year as new rocks become lodged or dislodged in the same location. Migrating adult coho salmon are known to leap several metres in the air to clear obstacles. There are long, shaded pools at the base of each waterfall that are several metres deep. These pools would provide protected, cool areas for holding. They would also enable adult salmon to swim to the bottom, effectively getting a “run-up” to leap over the falls. At the conditions SFC observed these falls, it is not likely they are a barrier to adult salmonid migration, nor to juvenile outmigration.

Figure 11. Left: Waterfalls 5-7 km from the mouth may be passable to adult salmon.

Right: Waterfall locations. An enlarged version of map is available in Appendix B.

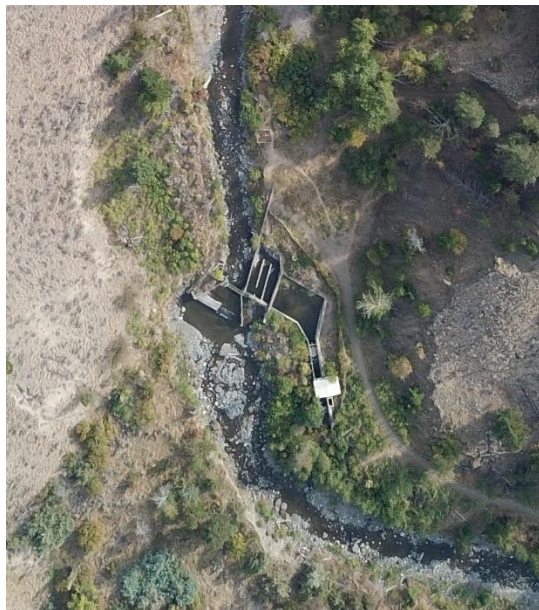
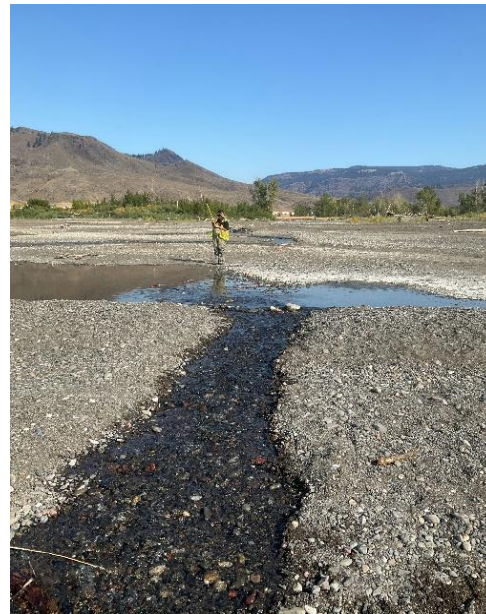
The water diversion structure (approx. 4 km from the mouth) obstructs fish access to several kilometres of high-quality spawning and rearing habitat upstream. In 2022, the structure was diverting large quantities of water out of the river during key coho spawning and migration timing. No holding or spawning fish were observed in the river during the SHIM. Braided stretches at the mouth of the river were barriers to fish passage until the water diversion was closed and flow levels increased downstream (Figure 12). Additionally, the infrastructure and piping that diverts the water has become dilapidated and leaks an unknown amount of this water into the ground, creating several artificial, disconnected wetlands at multiple downstream locations (Figure 13). Some wildlife may use these wetlands, but they have little to no fish value because they are not attached to the main channel. It is hard to quantify the

total impact of the water diversion. It obstructs access to high-quality habitat upstream, limits downstream flow during critical late summer periods and limits flow during fall migration and spawning.

Figure 12. Left: The water diversion structure obstructs fish passage to high quality habitat upstream. Right: Water diversion exacerbates low flow and high temperature conditions, as seen at the mouth.

- Combine short and long-term strategies for fish passage.
- Clear the existing fish ladder of debris and repair it for immediate results.
- Construct a bypass channel to ensure a long-term solution to fish passage.

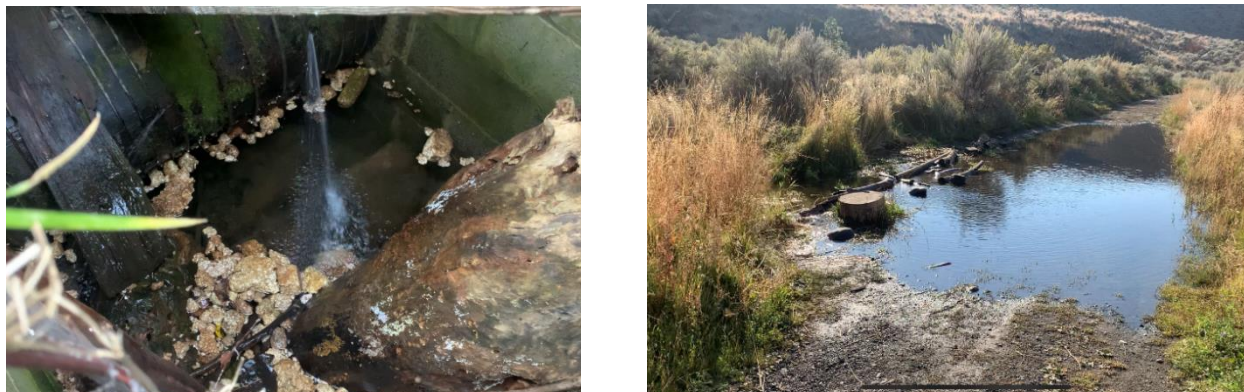
Figure 13. Left: Several leaks are obvious in an exposed section of pipe. Right: Leaking water has pooled in several locations and created artificial wetlands that are not connected to the river.

**Action 3: Address the degrading water diversion infrastructure.**

- Work with the Tranquille Farms property to transition to well or lake withdrawal for domestic water needs or fix the leaking pipe and closely monitor it and the associated structure.

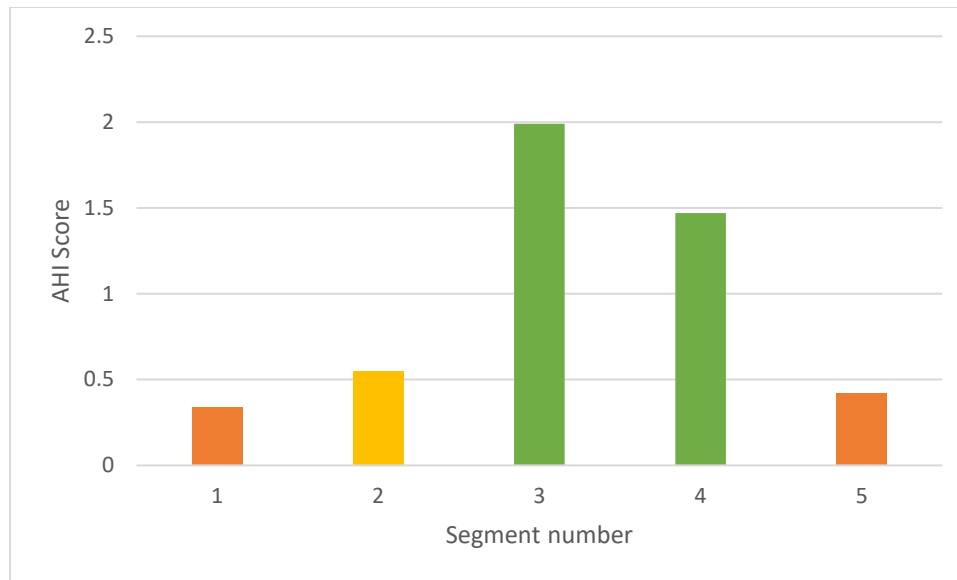
The centreline AHI results are outlined in Figure 14. The AHI generated considered not only the amount of fish habitat features, but the relative value of each feature to key fish species in the Tranquille River. Segments 3 and 4 have the highest potential productive capacity, making the greatest contribution to the overall aquatic habitat quality of the surveyed area.

Figure 14. AHI Segments Scores.
